PROPERTY CONDITION ASSESSMENT

(Updated from original February 13, 2017 PCA)

Town of Ross Fire and Police Building
33 Sir Francis Drake Blvd.- PO Box 320
Ross, CA 94957

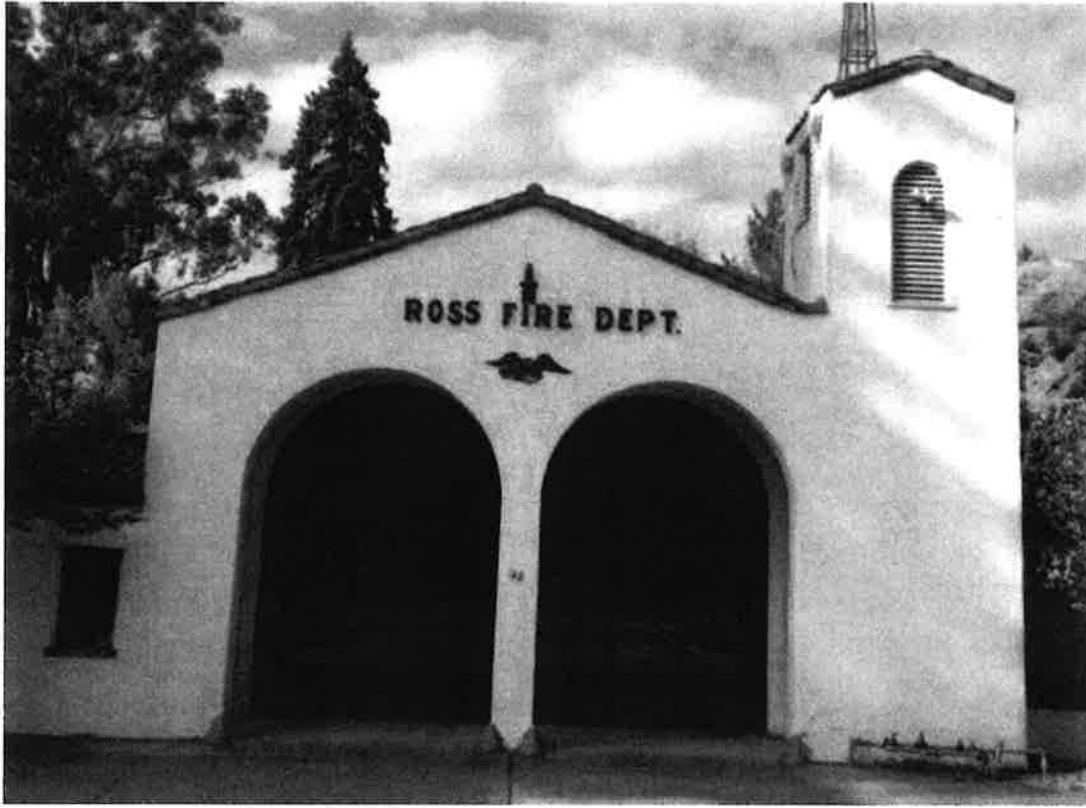
Image 1 Original Central Firehouse – Front elevation

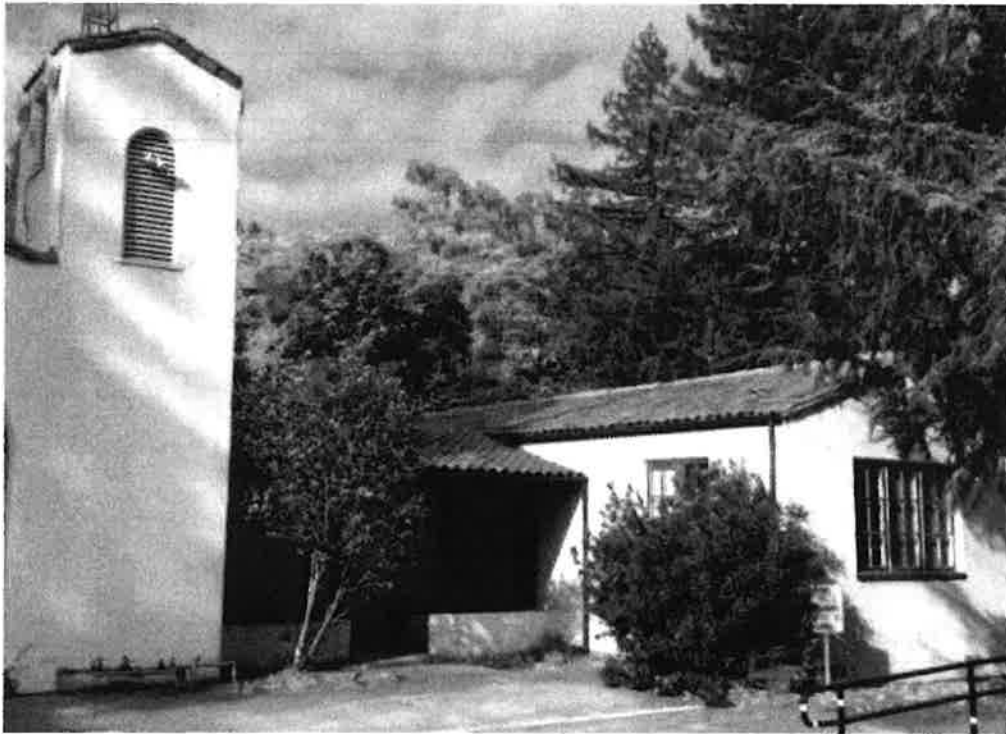
Image 2: North Wing

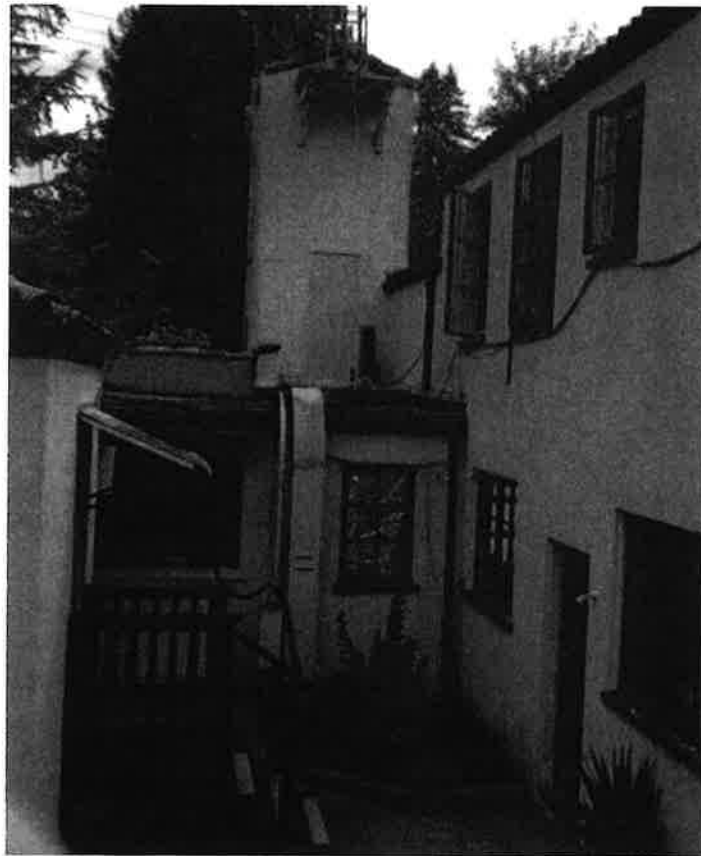
Image 6: Infill between central and north wing

RECOMMENDATION: Review infill construction in detail and analyze effects on original structure. Removal and/or reconstruction may be required.

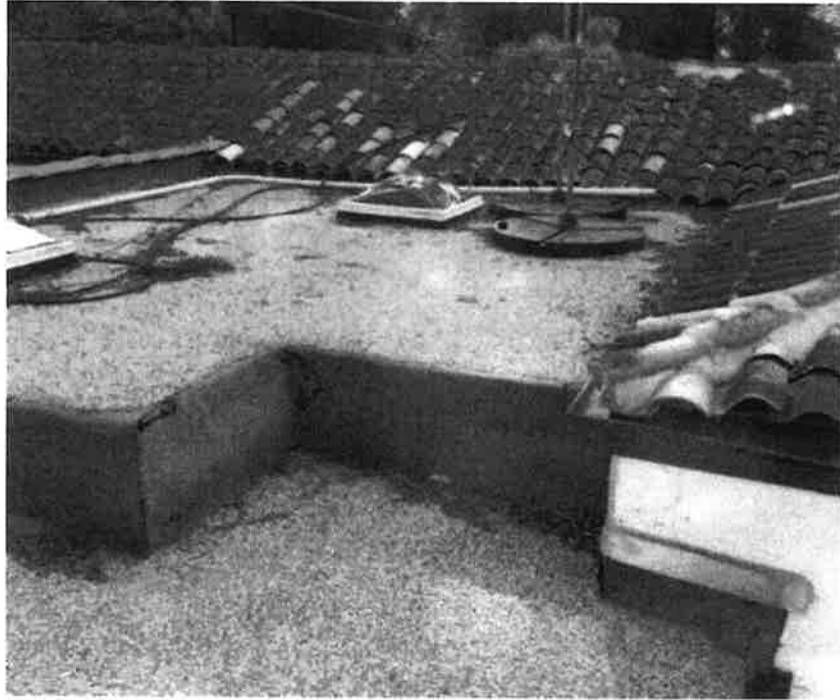
Image 7: Infill construction roof between central and south wing

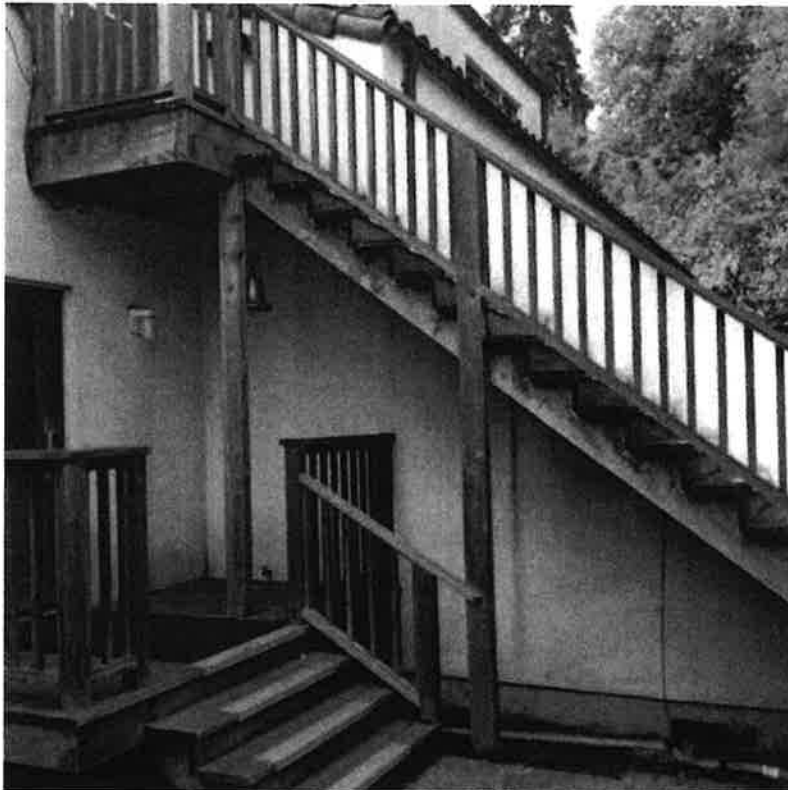
Image 8: Central firehouse dorm access stair (residential construction)

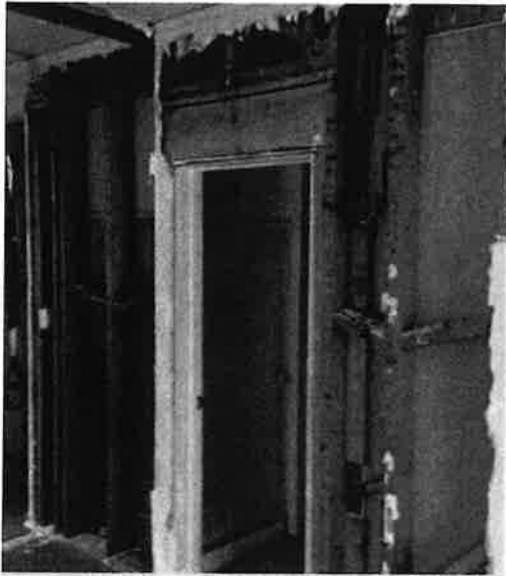
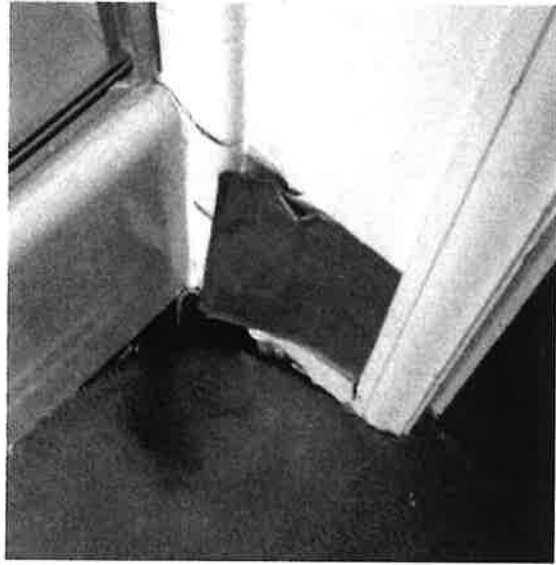
Image 9 and 10: South wing – Interior substandard construction

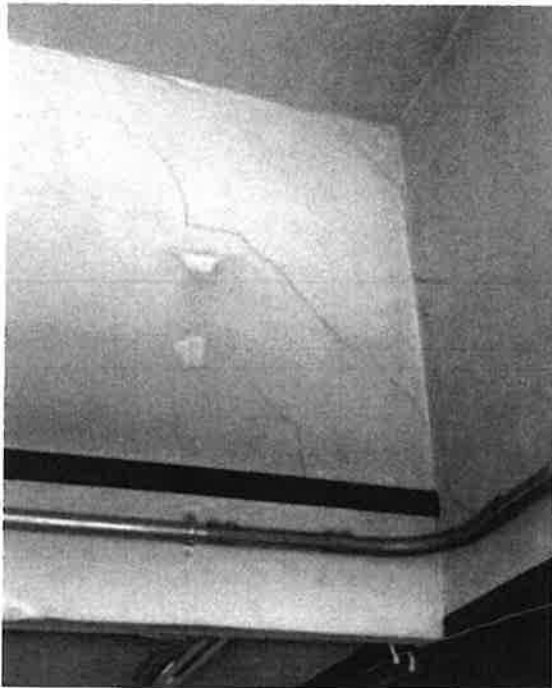
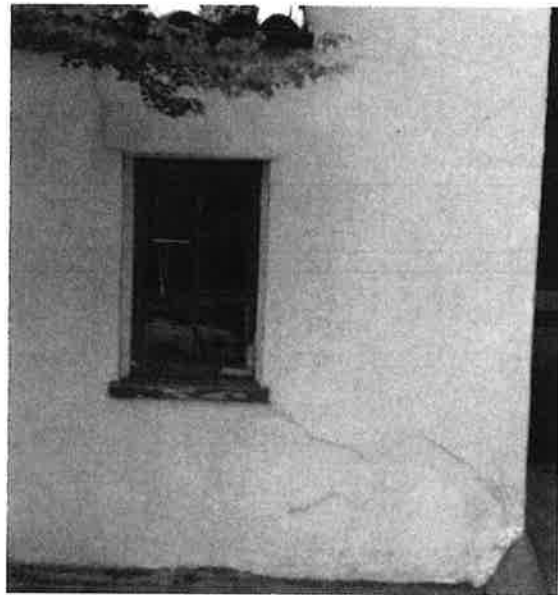
Image 11 and 12: Central firehouse – stucco cracks

- Exterior Stucco Cracks – The exterior walls and some interior walls at the center firehouse of the original building corner have some pronounced diagonal cracks. Recommendation: Inspect wood framing underneath stucco at areas of exterior cracks. Repair framing as needed and stucco.

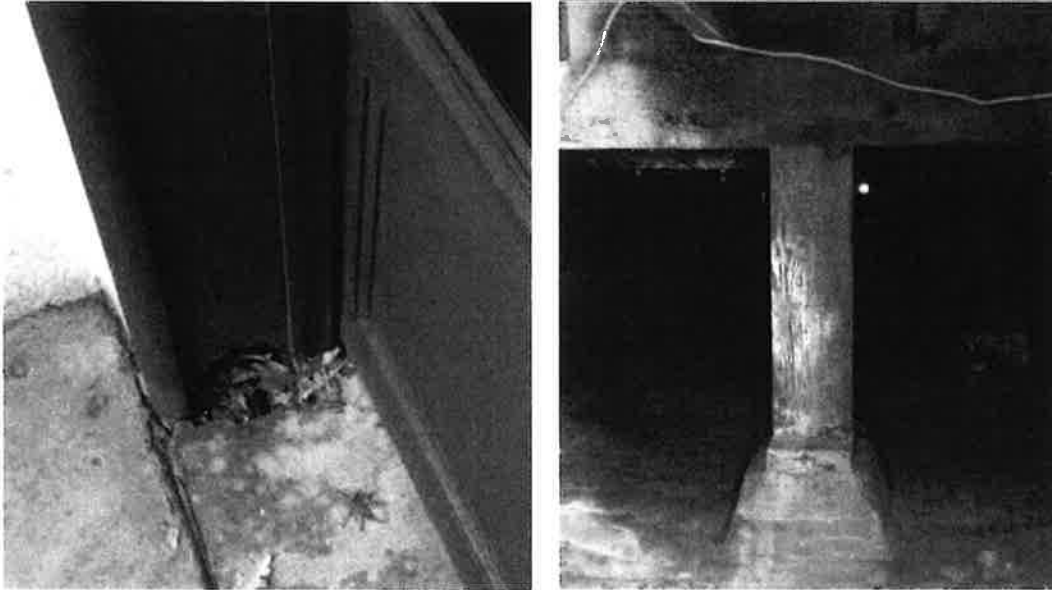
Image 13 and 14: Central and North Wing – decay and floor girder/post

- Floor Girder Connections – The ground floor framing girders and posts are not connected with metal hardware Recommendation: Add posts caps and bases to all connections.

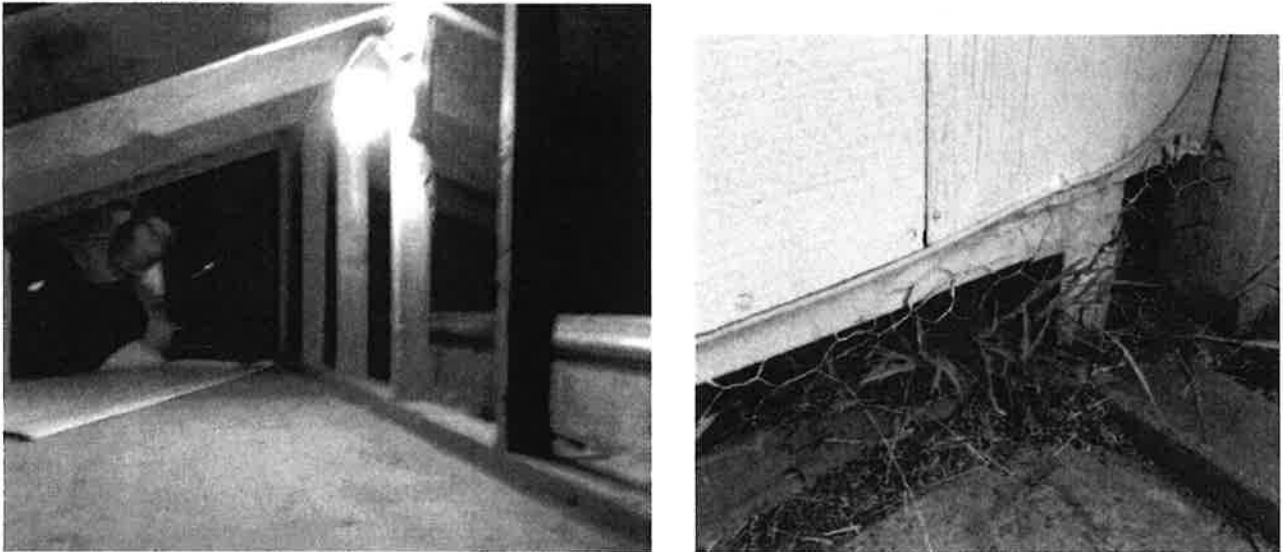
Image 15 and 16: Expansion and Infill – Roof framing and infill construction

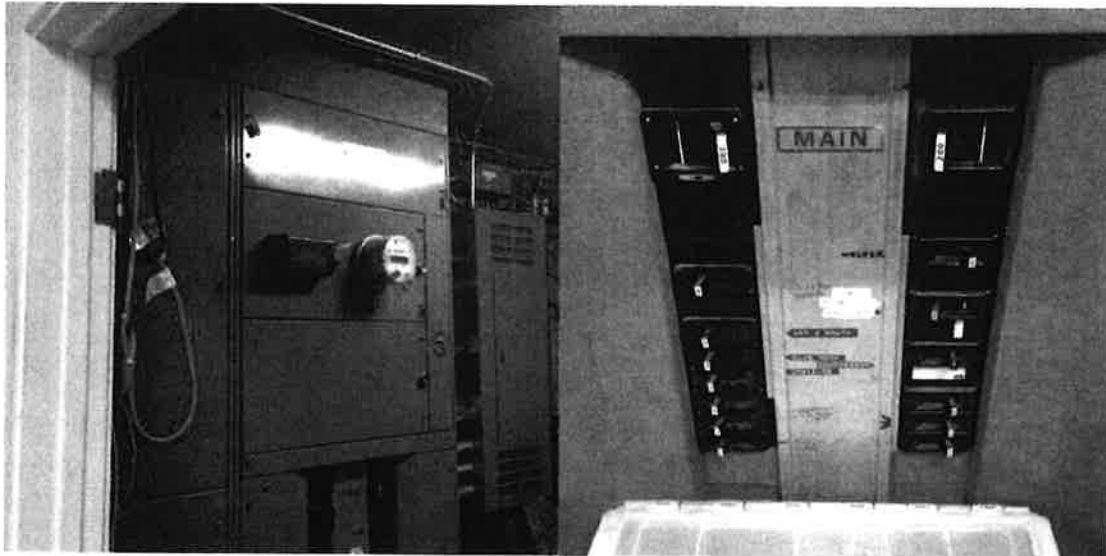
- a. The building electrical main service is provided by PG&E and feeds a 400-ampere main switchboard with a service voltage of 120/240V, single-phase. The switchboard is located in the main electrical room of the Fire Station portion of the building. The main circuit breaker is rated at 300 amperes and there is a secondary main circuit breaker rated at 300 amperes for the emergency generator feed. The switchboard is manufactured by Federal Pacific. Although vintage, the board showed no noticeable deficiencies. The utility service meter is #1003173037.

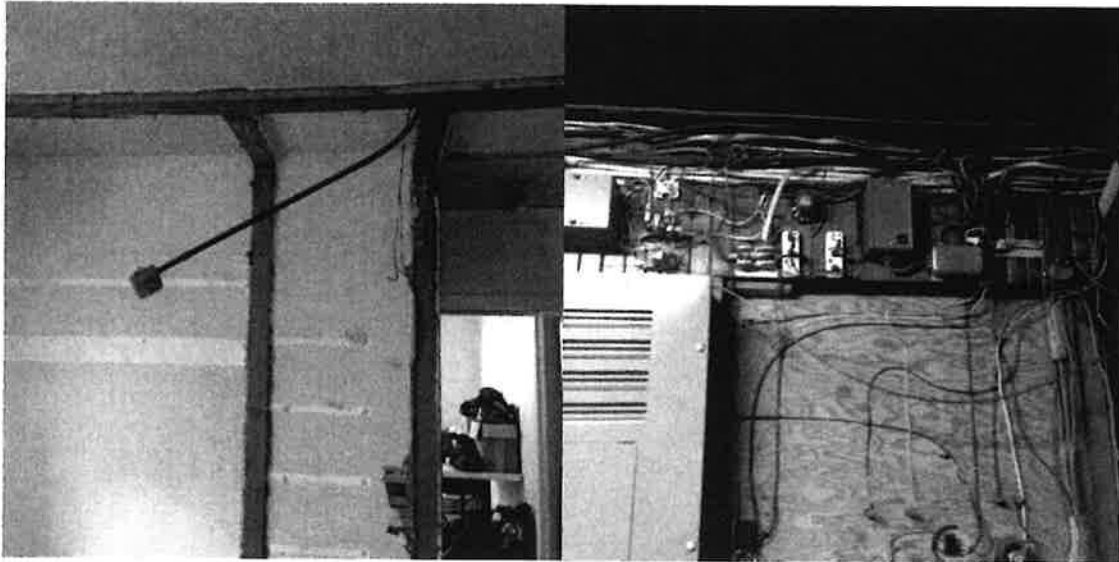
- a. The branch circuits are a mix of concealed and surface mounted boxes/conduit. Surface raceway (Wiremold) is also being utilized. The branch circuits are of varying ages and have been added to over time. In the Apartments, some branch circuitry is in a state of disrepair and some exposed Romex was noted. In the main electric room, exposed Romex is noted near and above the switchboard. Some branch circuits in the facility have been disabled/cut and it is not known if the serving overcurrent protection devices have been shut-off. The exposed Romex wiring and cut-off branch circuits are a safety concern.

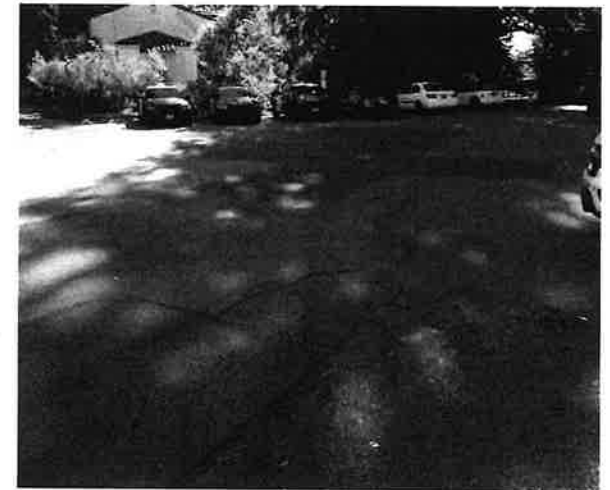
Asphalt cracking

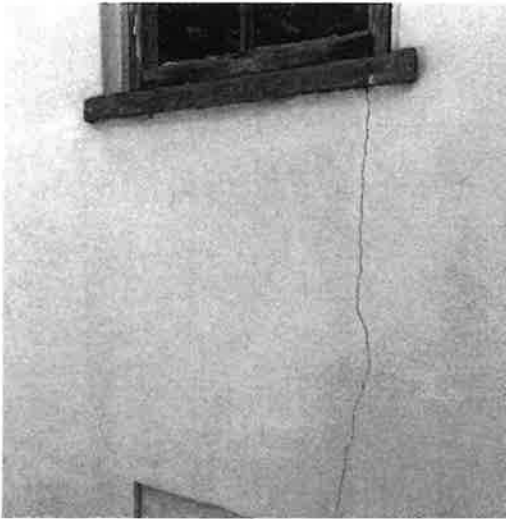
Typical Plaster Cracking

- Patch and repair all cracked plaster to prevent further water intrusion
- Re-route exposed wires and patch plaster
- Repair and replace dry rotted windows and doors to stop further deterioration.

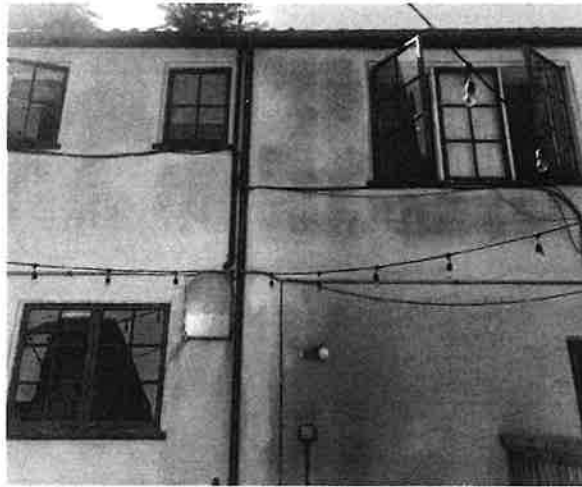
Exposed wiring, faded paint

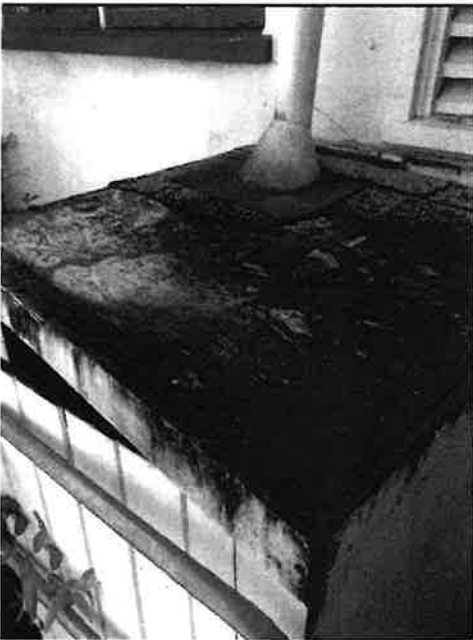
Roofing needs replacement

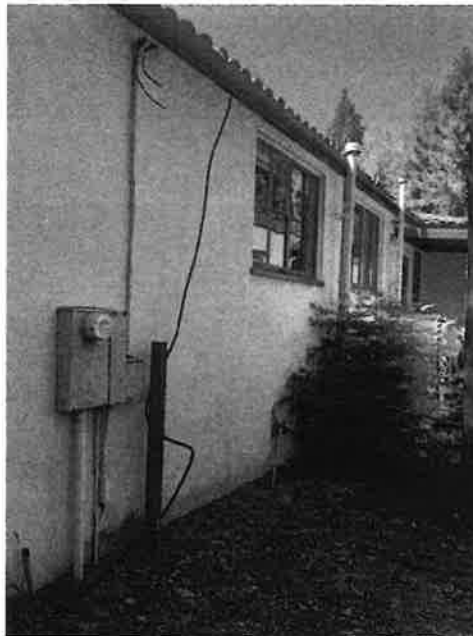
Soil contact with plaster

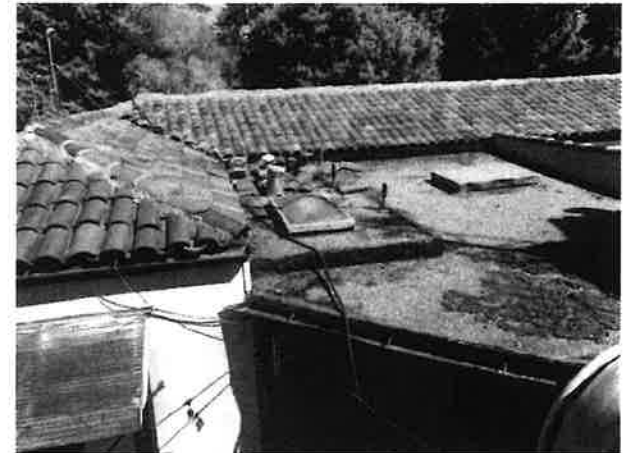
Roofing in need of repair, misc. exposed wiring.

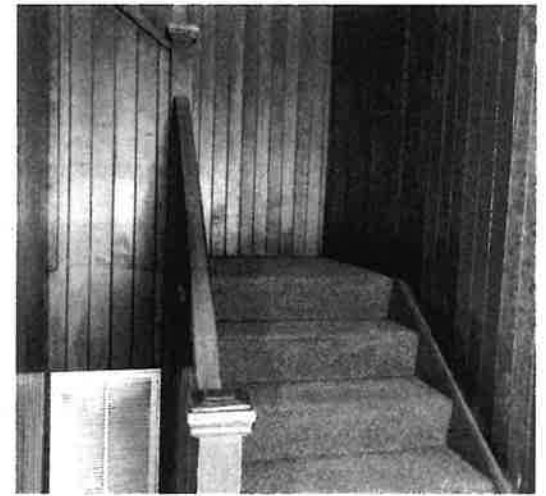
Non-compliant ADA stairs

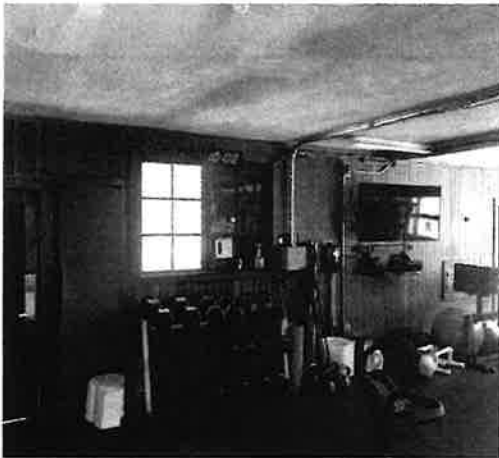
Ceiling repair

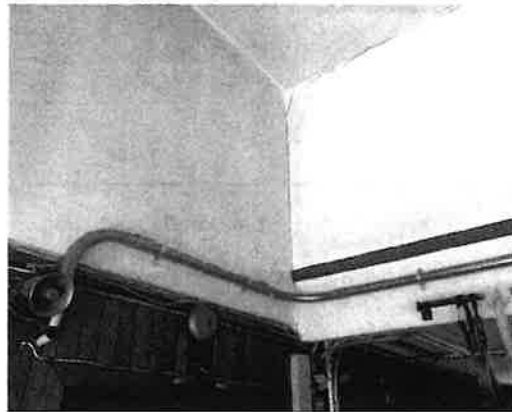
Interior plaster cracking

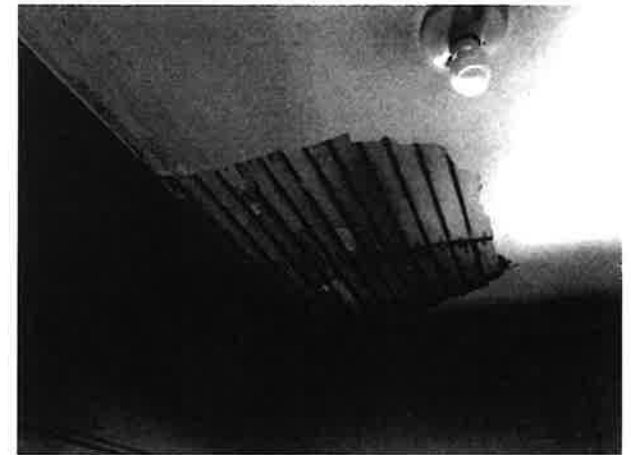
Ceiling damage

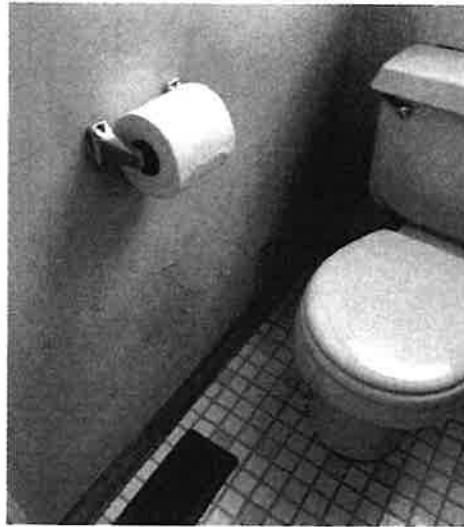
Moisture damage

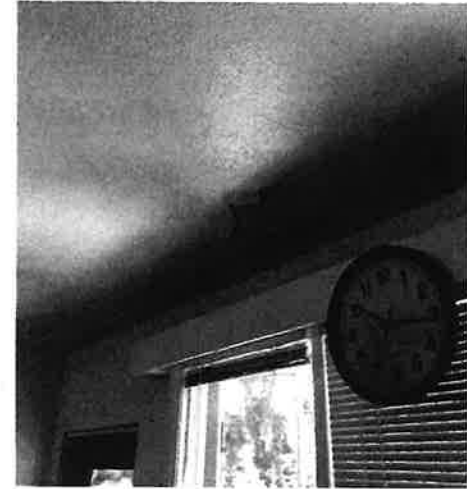
Ceiling Damage

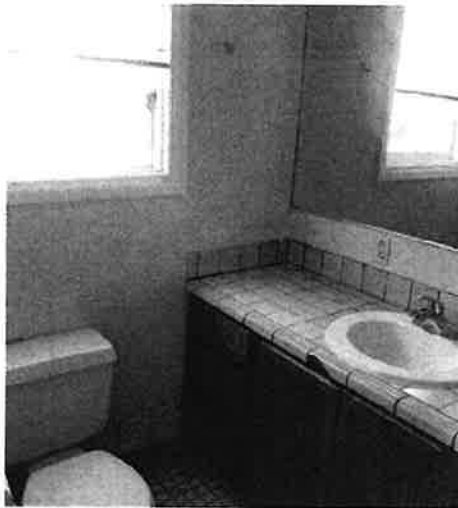
Broken counter top tile

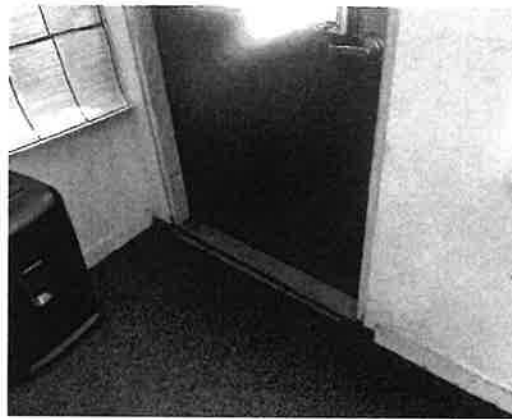
Water staining at threshold

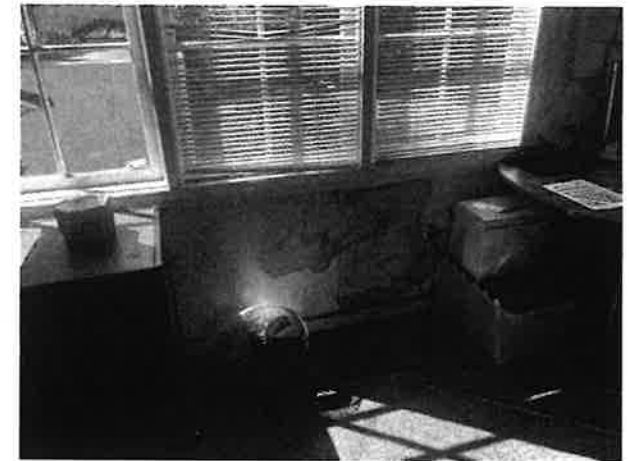
Water damage at exterior wall

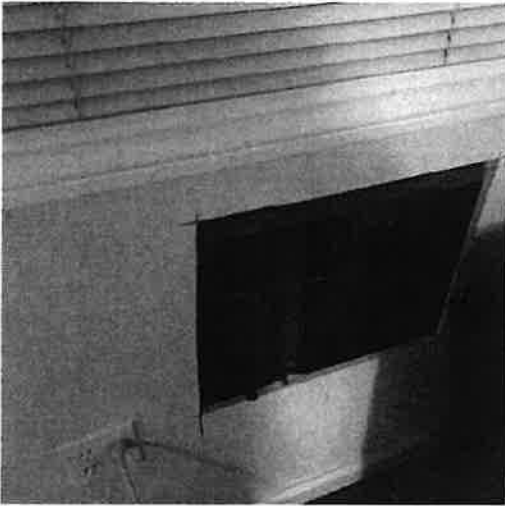
Portion of wallboard has been removed.

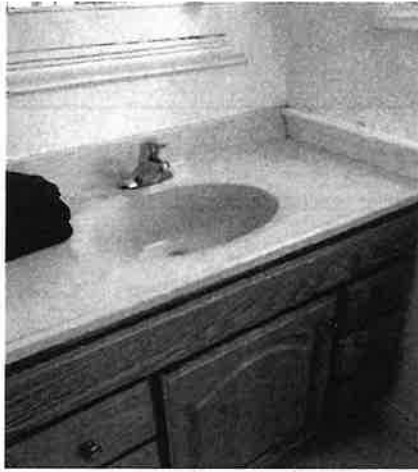
Moisture stains

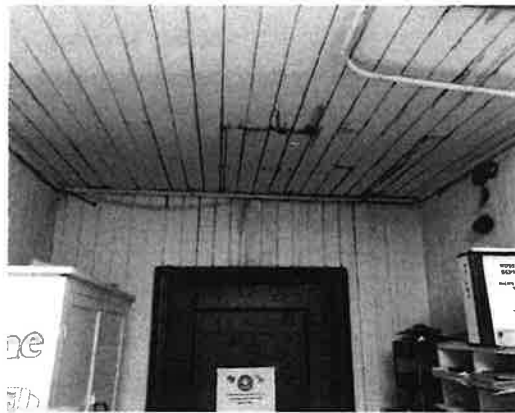
Water Damage

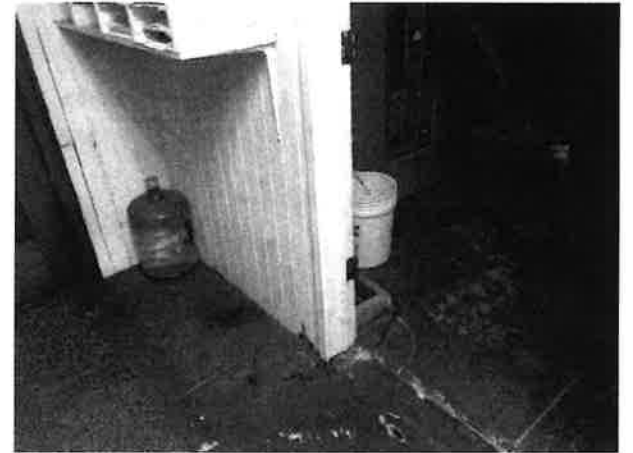
Water Damage

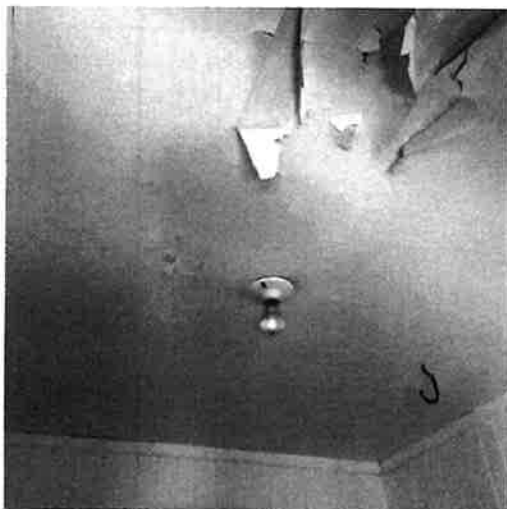
Water Damage

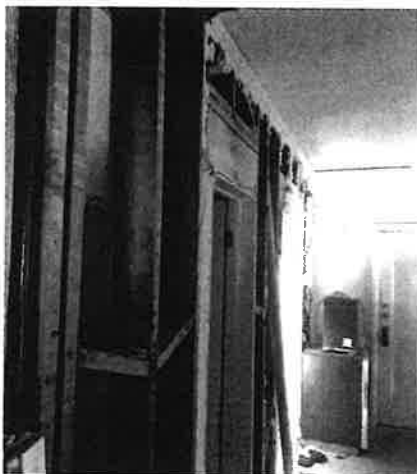
Partial demolition

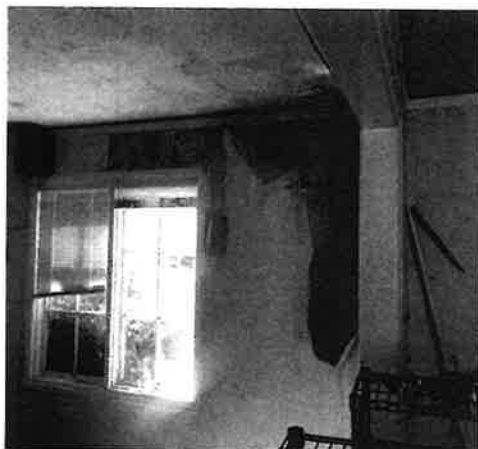
Water Damage

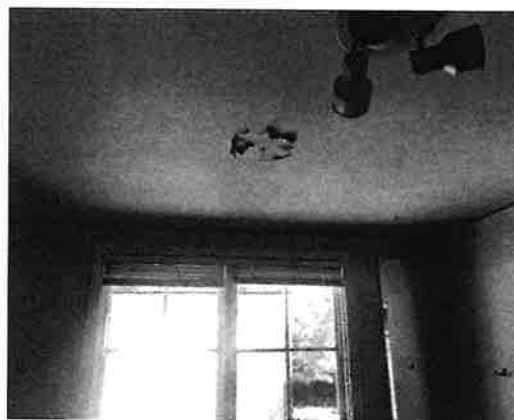
Water Damage

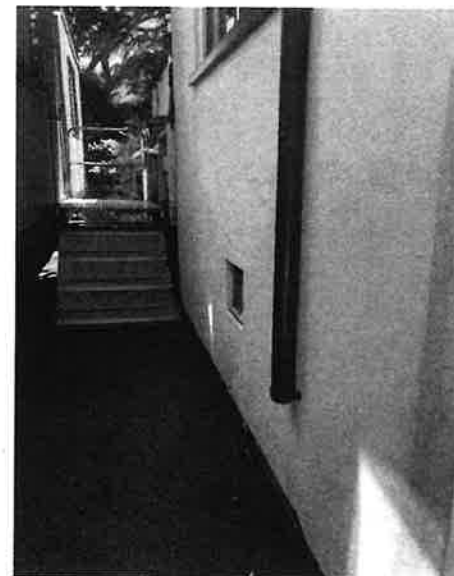
Unconnected rain water leader.
