PROPERTY CONDITION ASSESSMENT

Conditions Assessment Report

Ross Public Safety Building

33 Sir Francis Drake Blvd.
Ross, CA
ZFA Project: 16523.00

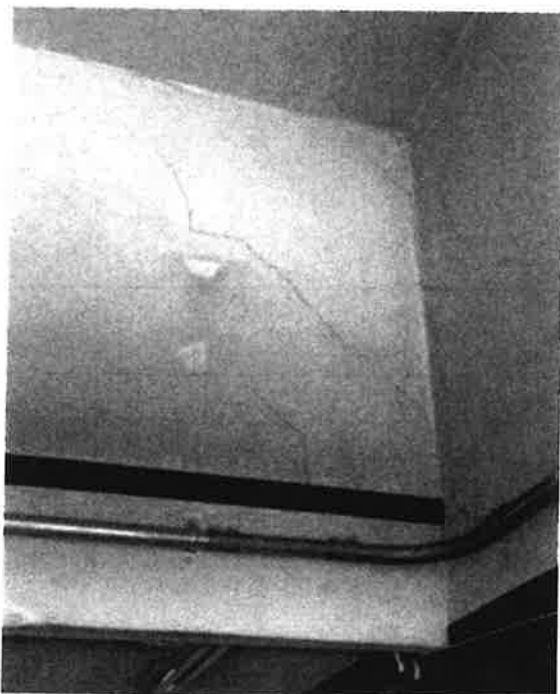
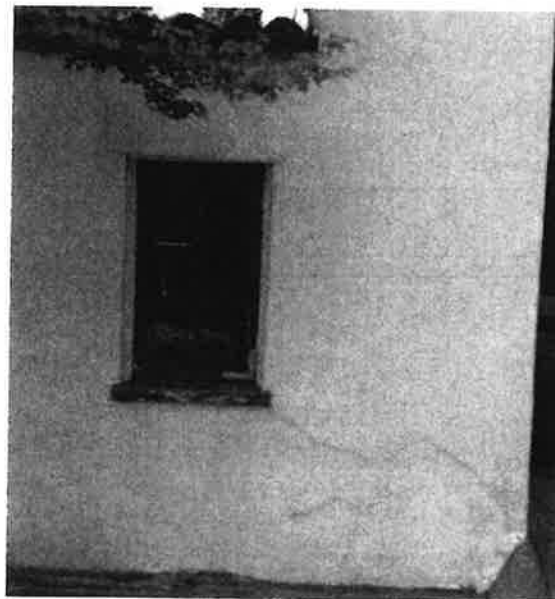
Image 11 and 12: Central firehouse – stucco cracks

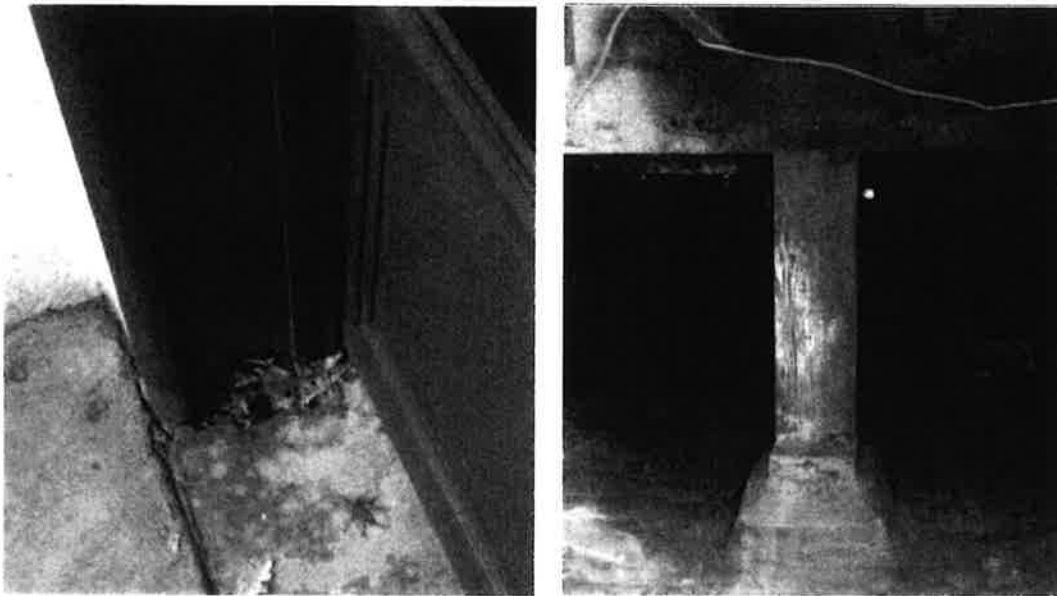
Image 13 and 14: Central and North Wing – decay and floor girder/post

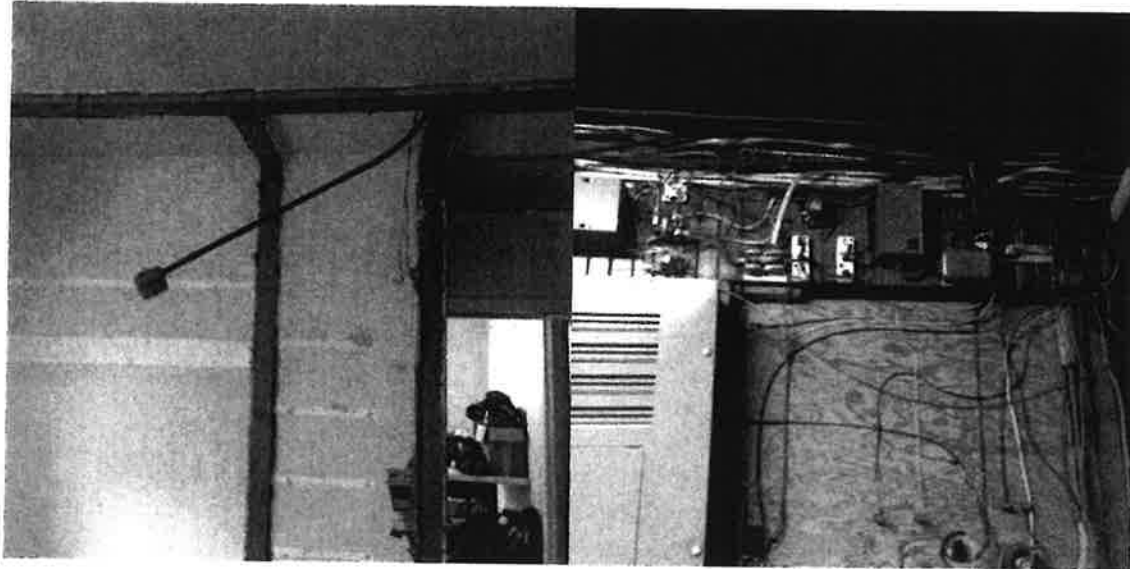
- a. The branch circuits are a mix of concealed and surface mounted boxes/conduit. Surface raceway (Wiremold) is also being utilized. The branch circuits are of varying ages and have been added to over time. In the Apartments, some branch circuitry is in a state of disrepair and some exposed Romex was noted. In the main electric room, exposed Romex is noted near and above the switchboard. Some branch circuits in the facility have been disabled/cut and it is not known if the serving overcurrent protection devices have been shut-off. The exposed Romex wiring and cut-off branch circuits are a safety concern.

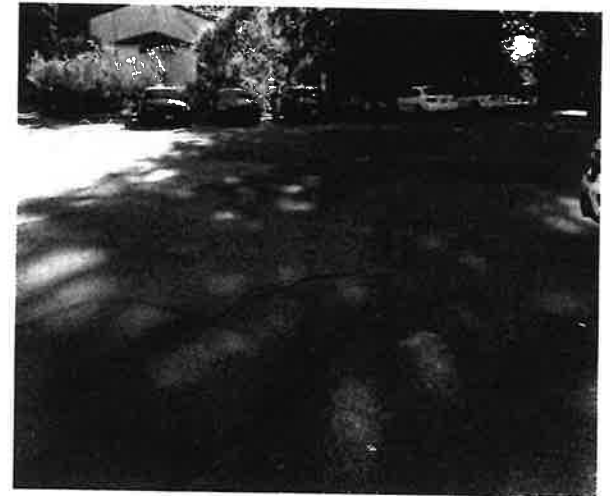
Asphalt cracking

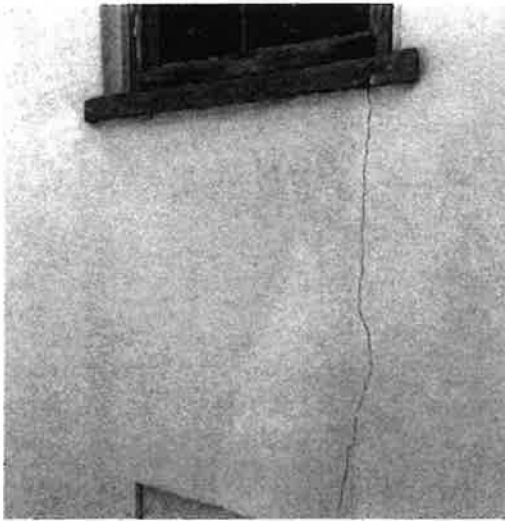
Typical Plaster Cracking

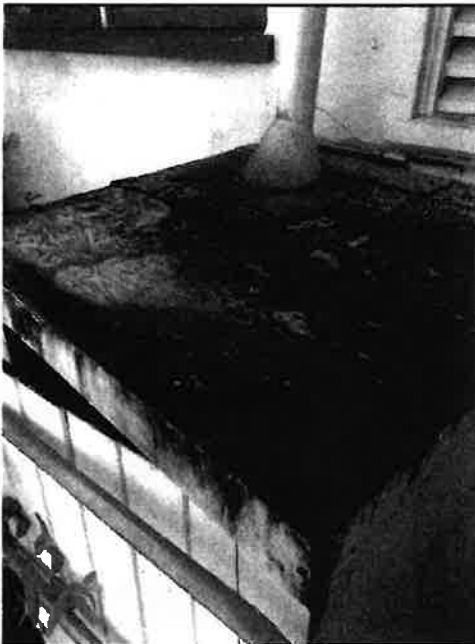
Roofing needs replacement

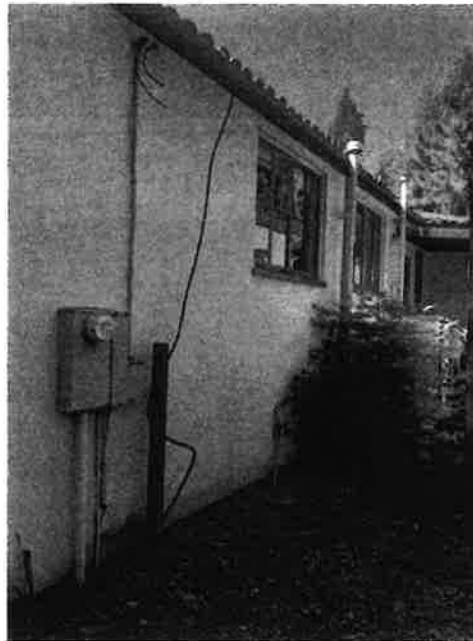
Soil contact with plaster

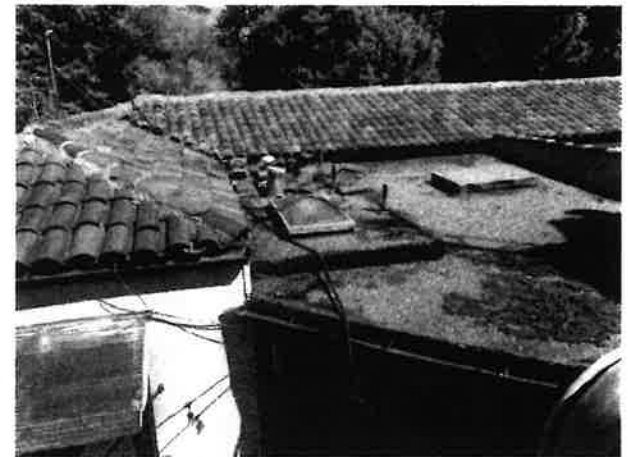
Roofing in need of repair, misc. exposed wiring.

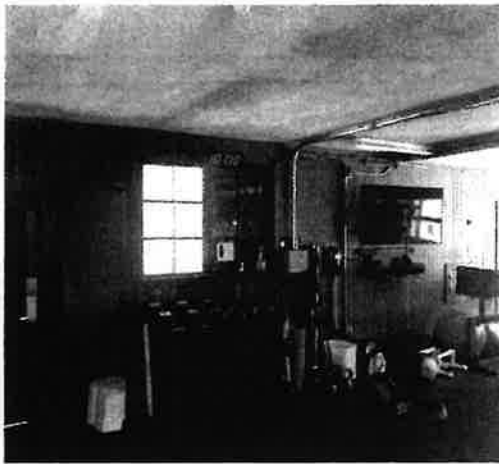
Ceiling repair

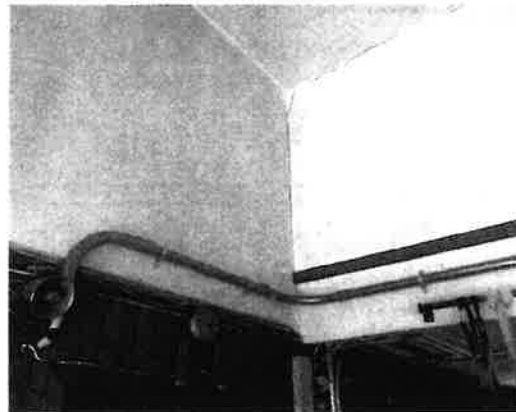
Interior plaster cracking

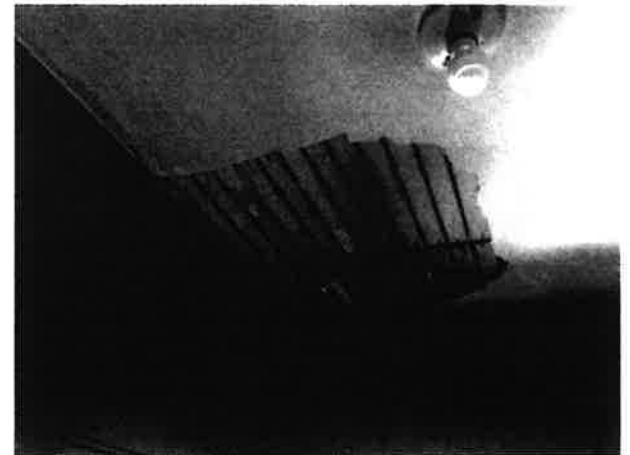
Ceiling damage

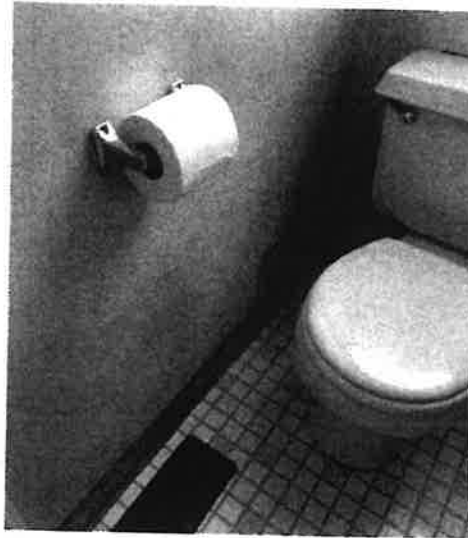
Moisture damage

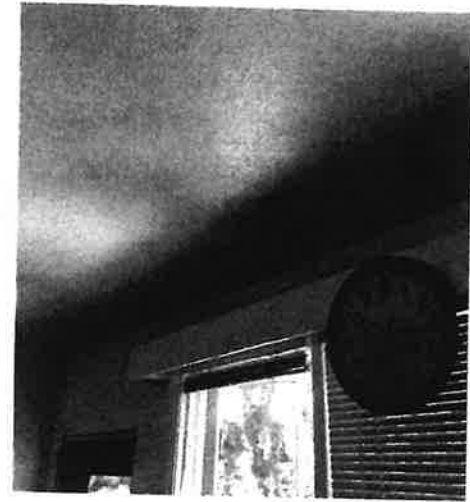
Ceiling Damage

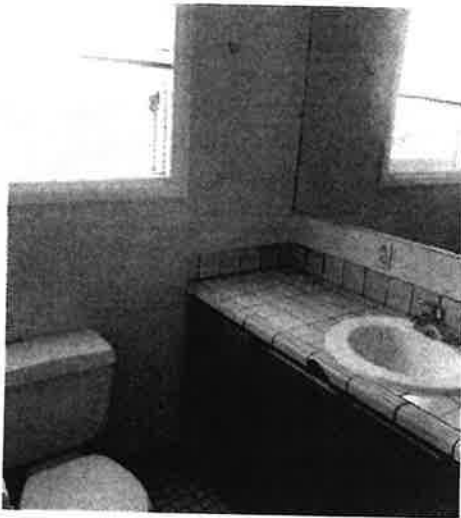
Broken counter top tile

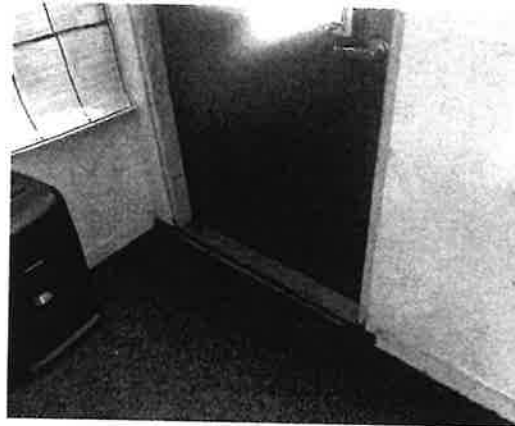
Water staining at threshold

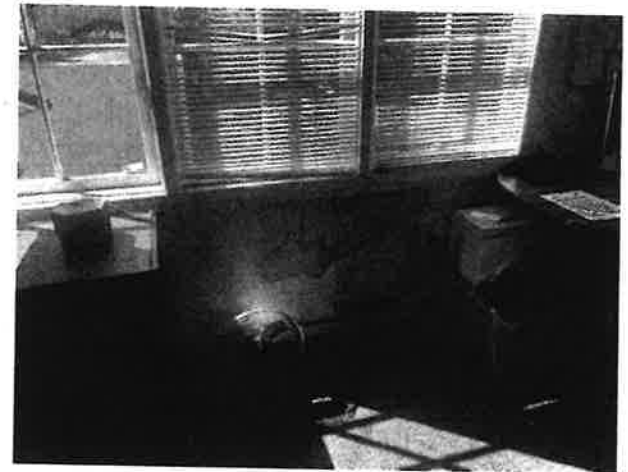
Water damage at exterior wall

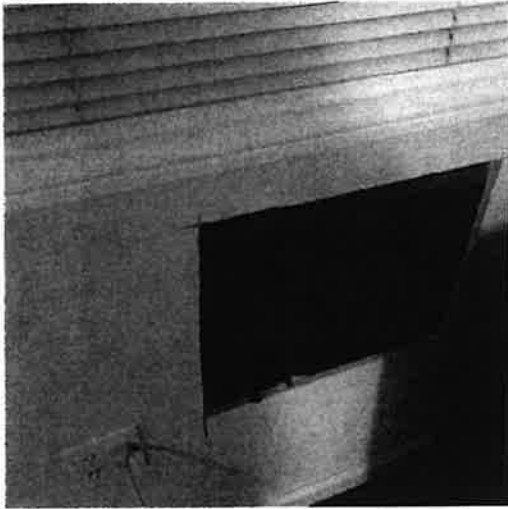
Portion of wallboard has been removed.

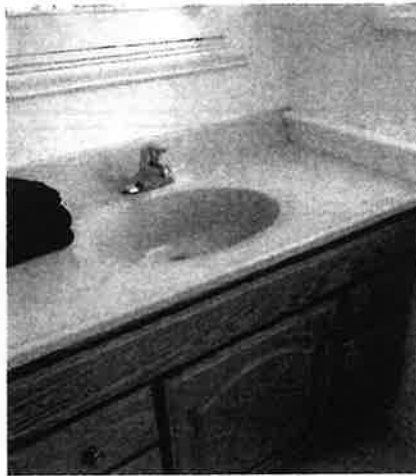
Moisture stains

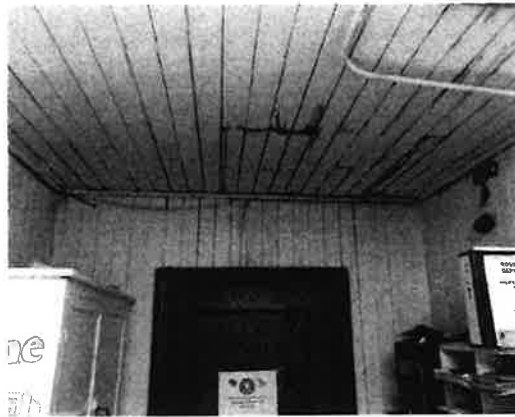
Water Damage

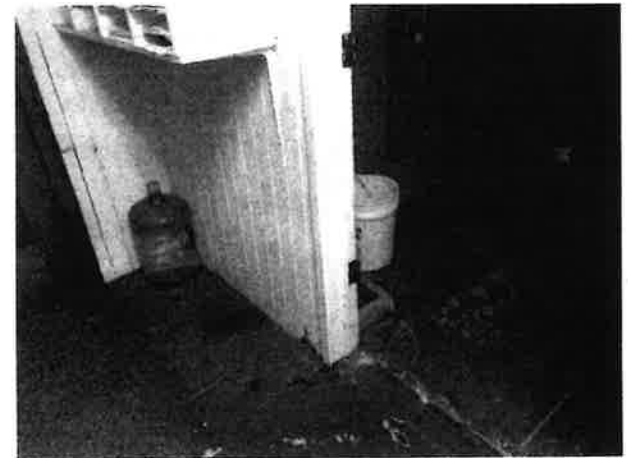
Water Damage

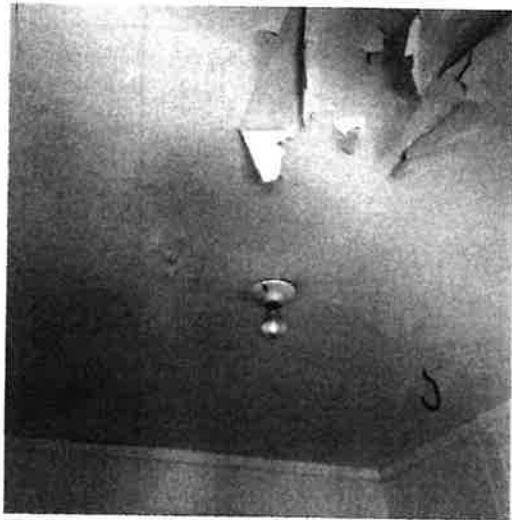
Water Damage

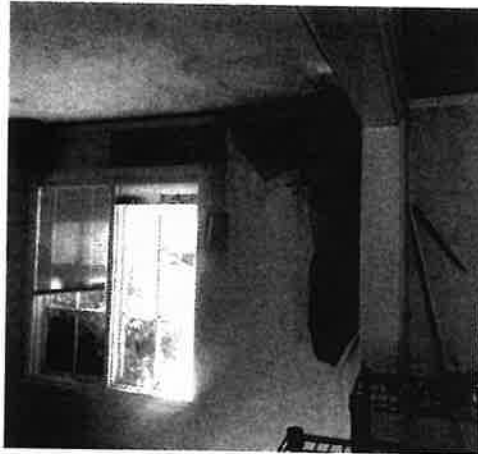
Water Damage

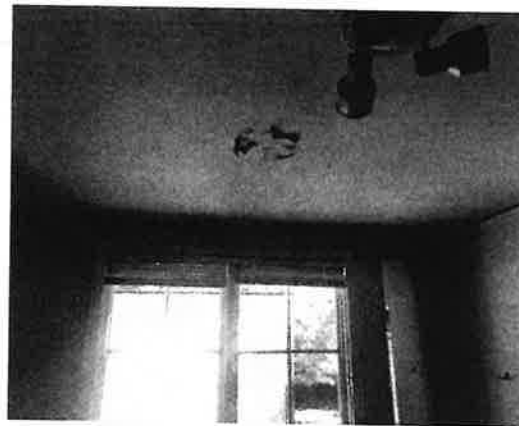
Water Damage

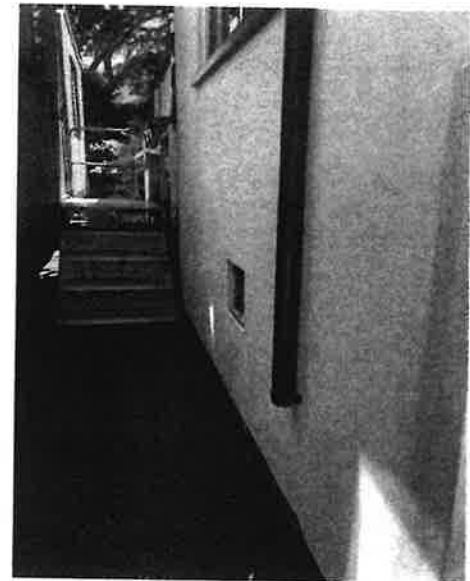
Unconnected rain water leader.
