### Comment on MT-2 Application

**RE: Creek Park redwoods, San Anselmo**

## ARBORIST REPORT

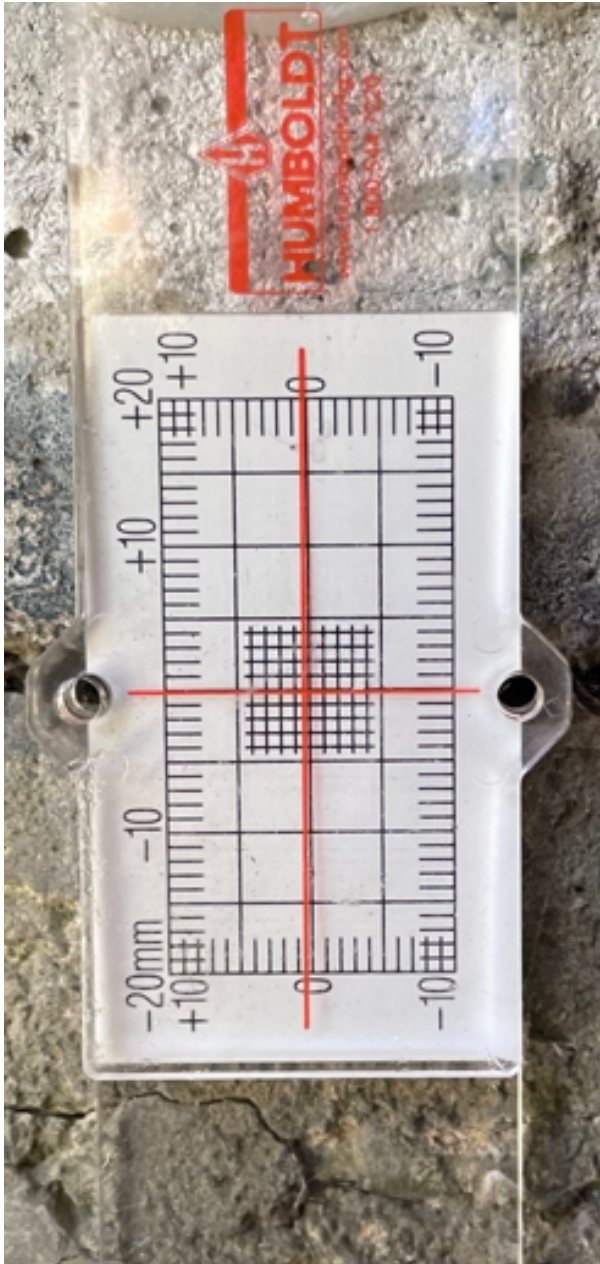
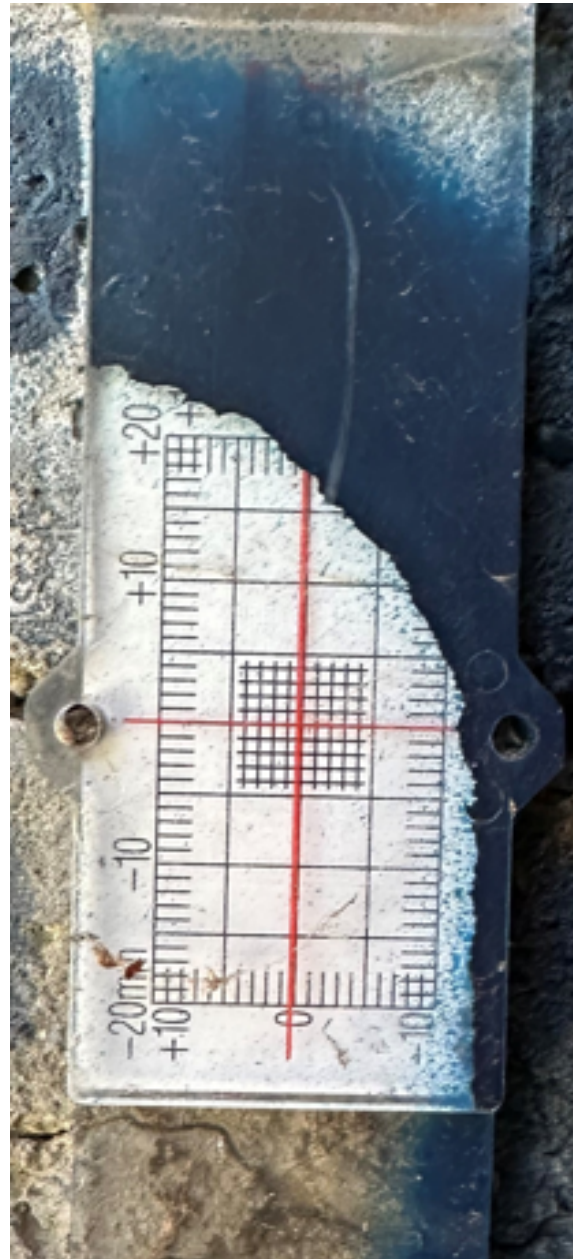
## Gauge 1

Nowhere is the reader informed that there are years of strain gauge reading conducted by San Anselmo DPW that show BB2 to be structurally stable. (see below) Questions regarding reuse of the plaza have been ignored while the District repeats debunked claims and the spite fence continues to blight the heart of downtown San Anselmo.

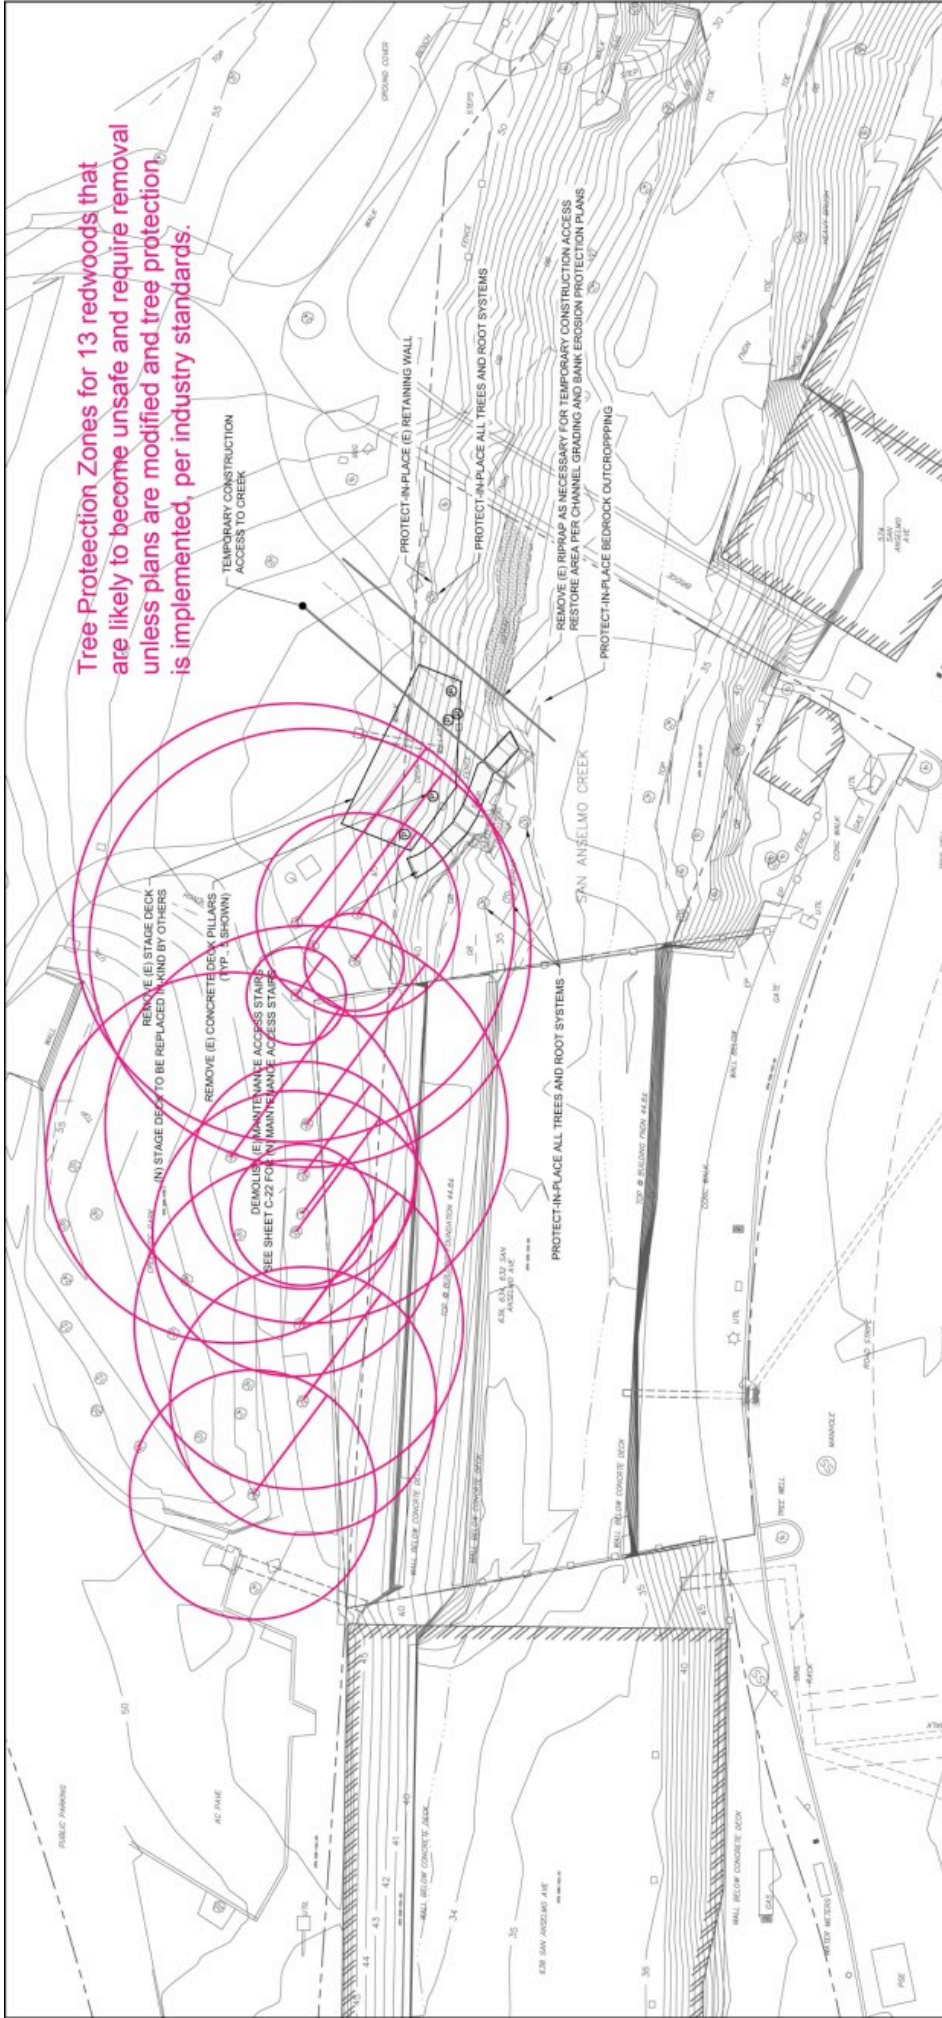
Trees that experience construction impacts, and particularly root losses, are likely to become hazards. Current plans show that a minimum of 13 redwood trees and 4 alders at this site will experience significant root losses, are likely to become hazards and will need to be removed. Most of the remaining trees in the park will experience significant and harmful impacts due to access and staging for the construction.

The attached photographs are of the site and the redwood trees that will require removal based on the design. Sheet G-7 by Stetson Engineers identifies tree locations and trunk diameters, and the attached markup shows tree protection zones for these 13 redwood trees.

Tree Protection Zones for 13 redwoods that are likely to become unsafe and require removal unless plans are modified and tree protection is implemented, per industry standards.
