ROSS, CALIFORNIA [21128]

PREPARED FOR STEPHEN AND HANNA ENSLEY JUNE 11, 2021

I. INTRODUCTION

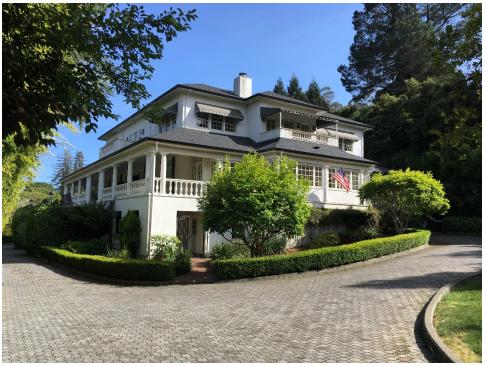
Figure 3: Oblique view of primary (northeast) façade (left) and northwest façade (right), looking south.

The residence at 3 Skyland Way is a two-story-over-exposed-basement wood frame building (Figure **3**). Originally constructed as a French Colonial Revival style residence with a hipped roof, attic dormers, and an irregular footprint, the residence now has a full second story and a generally rectangular footprint. The residence is set on a concrete and brick foundation and is primarily clad in stucco. The building is capped with a flat-on-hipped roof with a hipped roof form that wraps around all four sides of the residence between the first and second stories. The roofs are clad in asphalt shingles and an interior, stuccoed chimney is located on the northwest side of the building. The residence features a porch at the main level that wraps around the two side facades but is enclosed as a sunroom at the northwest façade. The porch is supported by wood Tuscan columns, is enclosed by wood spindle balusters, and has wood board floors and soffits. The columns are evenly spaced across the porch, except where three are clustered in each corner. Typical windows are multi-lite wood casement windows or eight-over-eight wood hung windows.

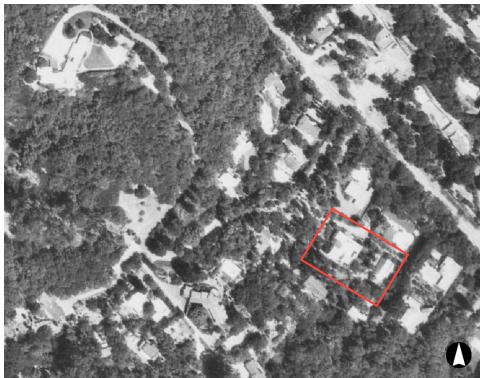
Figure 42: 1965 aerial photograph of subject property and vicinity. Source: UC Santa Barbara Special Collections. Cartwright Aerial Surveys, Flight CAS-65-130, Frame 40-43.

A 1965 aerial photograph captured the subject property a few years after the Ross Acres subdivision was recorded, showing that the properties bordering 3 Skyland Way were developed with houses **(Figure 43)**. The photograph also shows the residence at 3 Skyland Way took on a square footprint different from the L-shaped footprint visible on the 1947 aerial photograph.

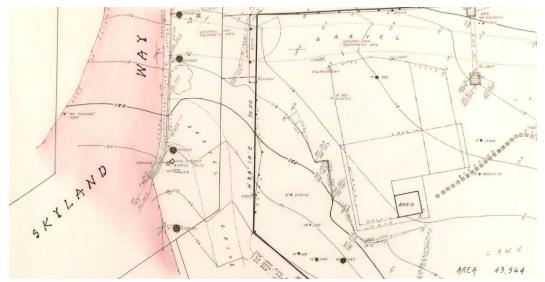
Figure 43: Portion of property survey illustrating the west site perimeter and shed that was demolished in 1984. Source: Source: Marin County Free Library, Anne T. Kent California Room.

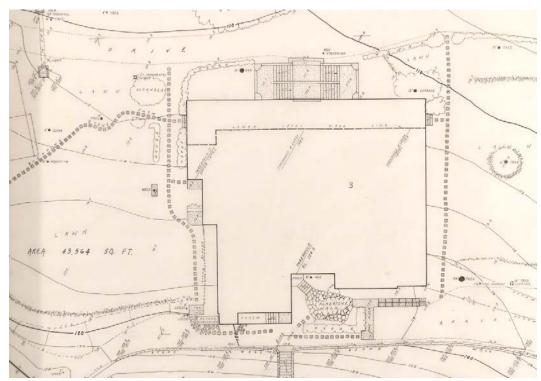
Figure 44: Portion of property survey illustrating central area of the property and subject residence's footprint, prior to the 1984 remodeling project. Source: Source: Marin County Free Library, Anne T. Kent California Room.

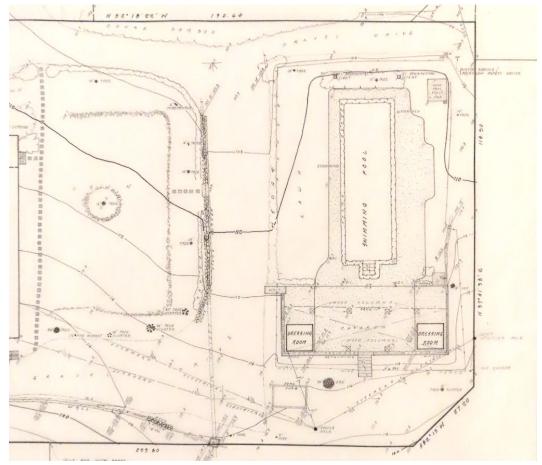
Figure 45: Portion of property survey illustrating the eastern area of the site with a lawn aera and rectangular in-ground swimming pool with dressing rooms. Source: Source: Marin County Free Library, Anne T. Kent California Room.

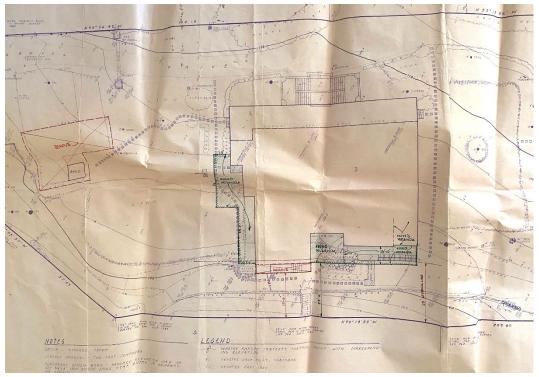
Figure 46: Site plan of the subject property showing areas where additions were added in 1984 (shaded in green). A garage, removed during the project, stood to the west of the residence. Source: Provided by owner.

- 1984: A major remodel of the residence was completed, including insertion of garage within the raised basement level, likely recladding the basement level with stucco, construction of a one-story rooftop addition, addition of a veranda to west façade, and addition of a veranda and solarium to rear south façade. The original hip roof of the residence was irreversibly altered, changing the form and massing of the residence. Additional changes included replacement of two preexisting pool changing rooms.

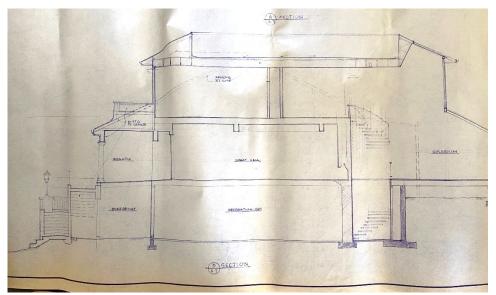
Figure 47: Section drawing showing alteration of hip roof and original rear wall (shown in dashed lines) in 1984. Source: Provided by owner.

The remodeling project altered the original hip roof of the residence and resulted in construction of verandas along the south and west façades. The veranda on the west façade was connected to the original full-width veranda at the primary façade , forming the existing wrap-veranda. An enclosed solarium was also built on the rear façade, filling a recessed area of that façade. In addition to these alterations to the residence, a preexisting garage located to the west of the residence was demolished. The origins of the garage were unable to be confirmed with available property documentation. A new garage bay, located at the east end of the raised basement level, was cut into the primary façade. It appears that to accommodate this new garage within the base of the residence, the perimeter walls of the raised basement were further enclosed and covered with non-historic stucco. By 1984, the residence's primary façade had been additionally altered with the existing staircase (**Figure 47 and Figure 48**).

The 1984 remodel introduced new verandas at the south and west façades of the building, a solarium at the center of the south façade, and a one-story rooftop addition. The rooftop addition altered the preexisting rear wall of the building and replaced the majority the original hip roof with the existing roof form. Original dormer windows were removed in some locations and altered in others to accommodate the addition.

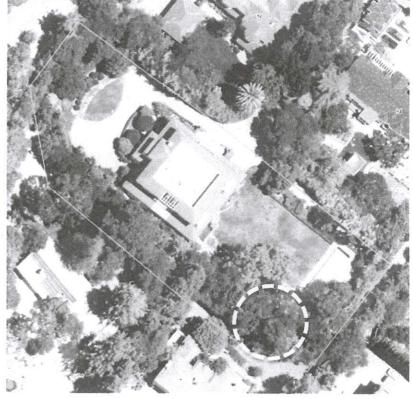
The home at 3 Skyland Way in Ross (APN: 072-211-12) was built in 1899 and remodeled in 1980 on a nearly level 1-acre property (outlined in yellow, right). Property improvements include a gated driveway and stone paver driveway leading to a single-family home and pool. This property is nicely landscaped with both native and ornamental trees, shrubs, and perennial flowers. The subject tree is rooted southwest of the pool (circled in white, right).

The subject tree is a coast live oak measuring 40" in diameter at breast height. Its structure consists of a well-tapered lower trunk that divides into several scaffold limbs at about 10' above grade. This tree has an advanced infection of *Phellinus gilvus*, which led to the catastrophic trunk failure on August 20, 2017.

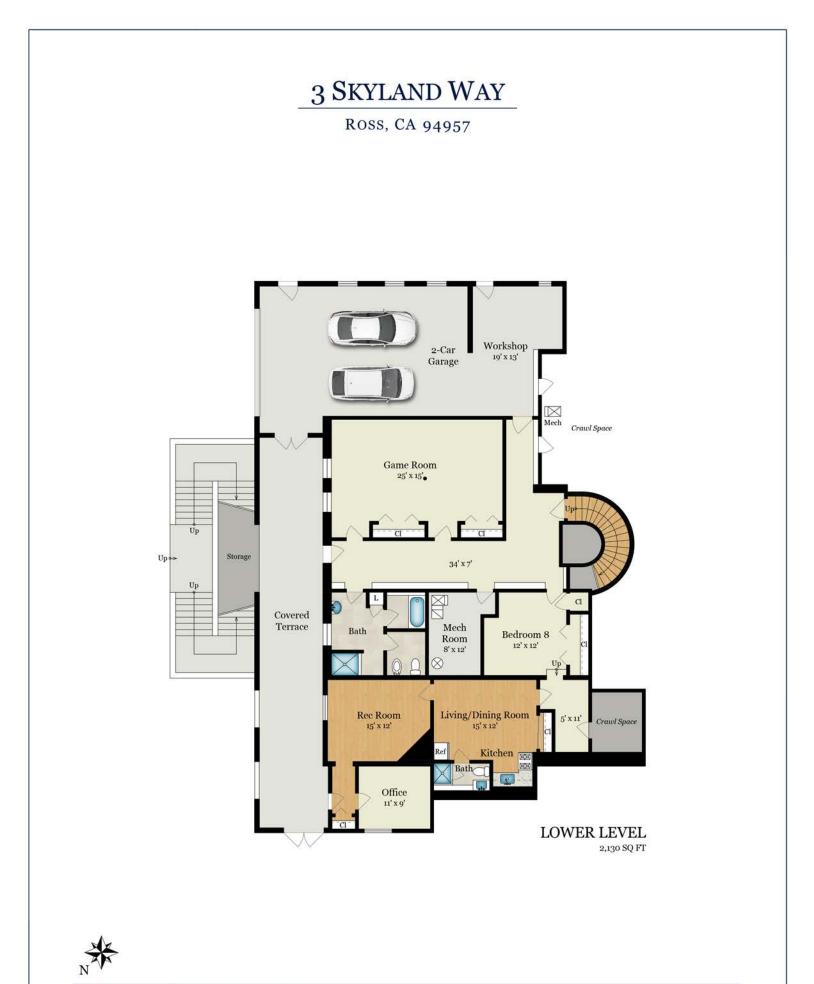
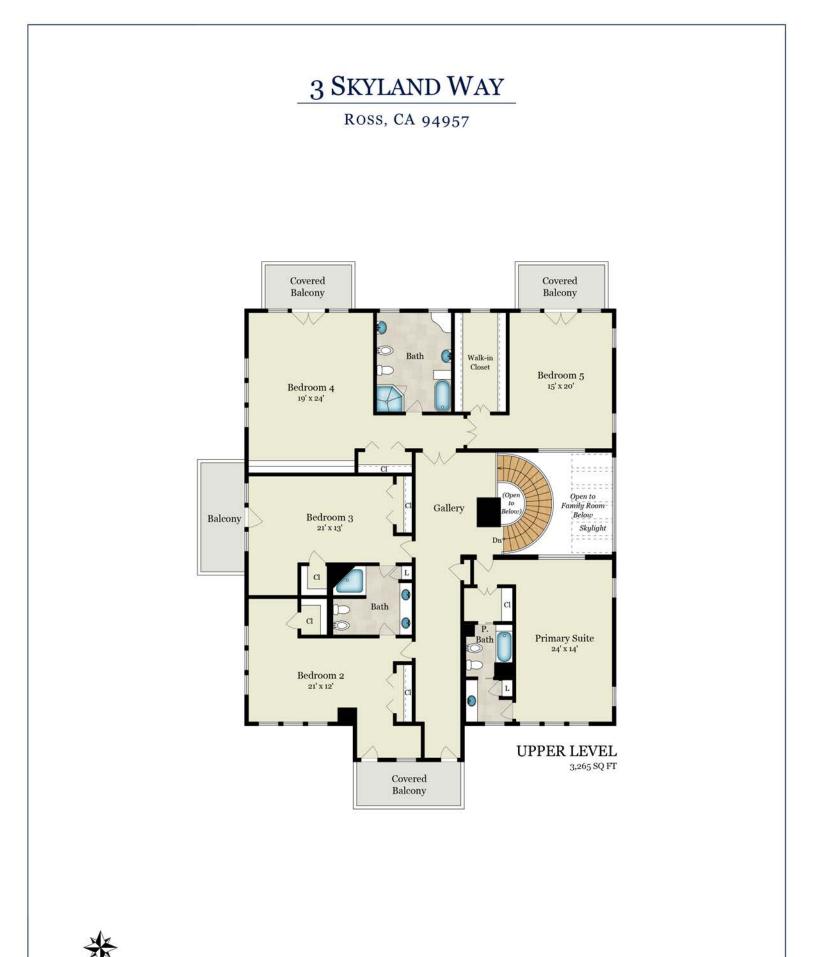
The following floor plans and site plans illustrate the existing conditions of the subject residence and site and were provided to Page & Turnbull in April 2021.
