PROPERTY CONDITION ASSESSMENT

(Updated from original February 13, 2017 PCA)

Town of Ross Fire and Police Building
33 Sir Francis Drake Blvd.- PO Box 320
Ross, CA 94957

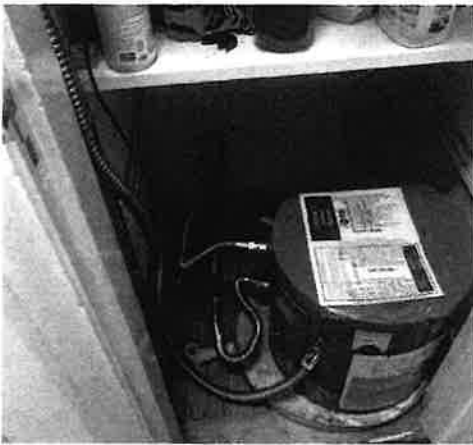
Police Station Water Heater

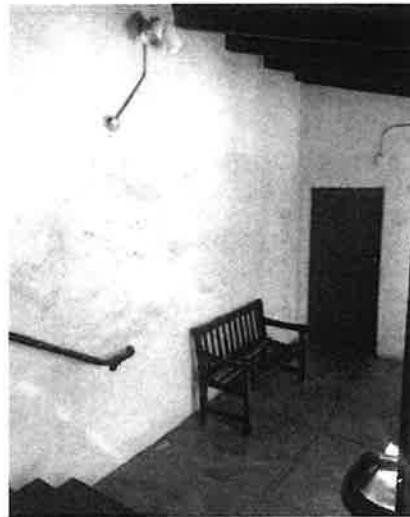
Faded plaster paint
