PROPERTY CONDITION ASSESSMENT

(Updated from original February 13, 2017 PCA)

Town of Ross Fire and Police Building
33 Sir Francis Drake Blvd.- PO Box 320
Ross, CA 94957

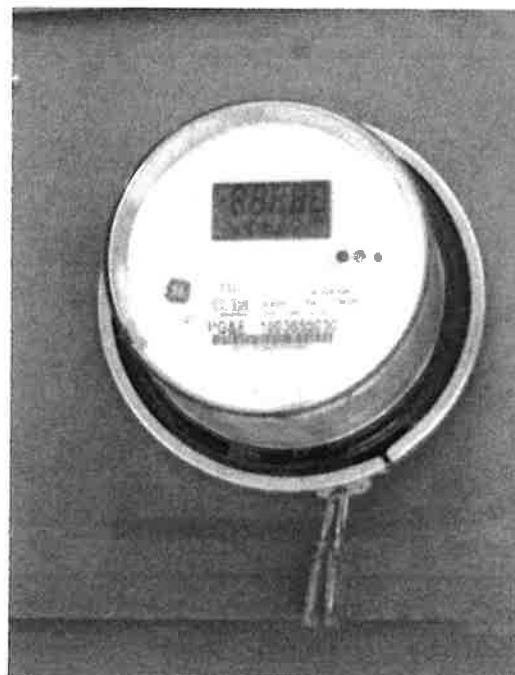
- c. Another small 120/240V, single-phase exterior service is fed overhead and is located on the backside of the portable unit near Apartment B. The service meter is #10036550302.

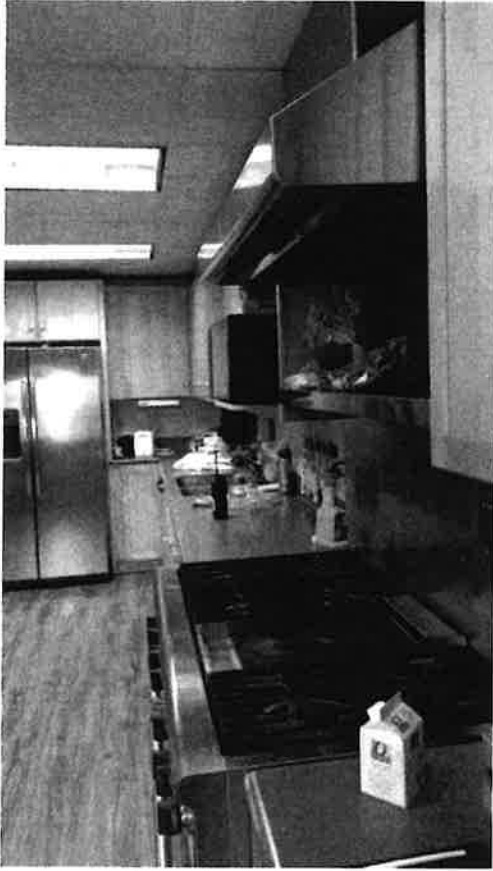
Figure 1.

- The kitchen is provided with a stainless steel hood over the existing gas-fired range. Currently the hood does not extend 6" past the front edge or sides of the range as recommended by engineering best practices (figure 1). The age of the hood could not be determined.

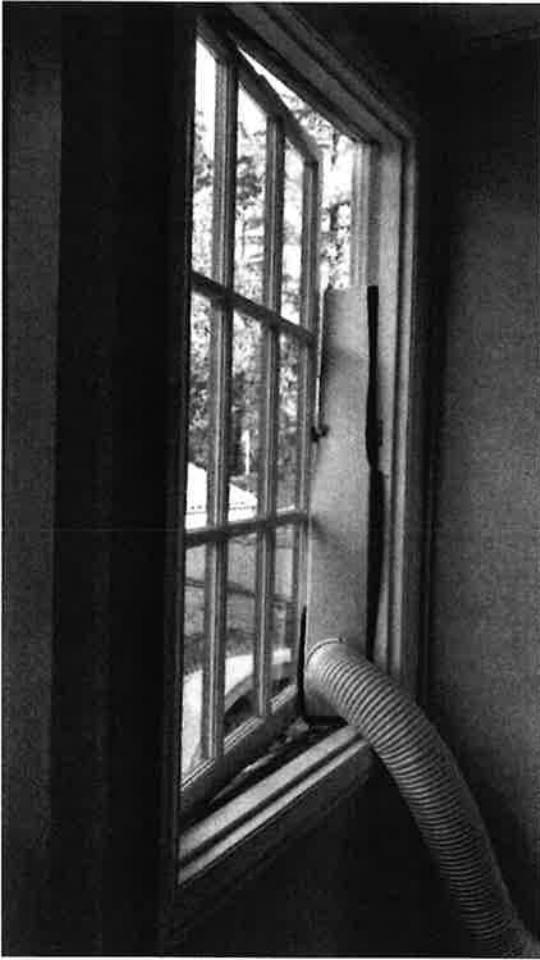
Figure 3.

- As it currently exists, there is a dehumidification unit located in the hallway of the residential portion of the building on the second floor. The unit is currently ducted out through a permanently open unit that is not sealed properly (figure 3).

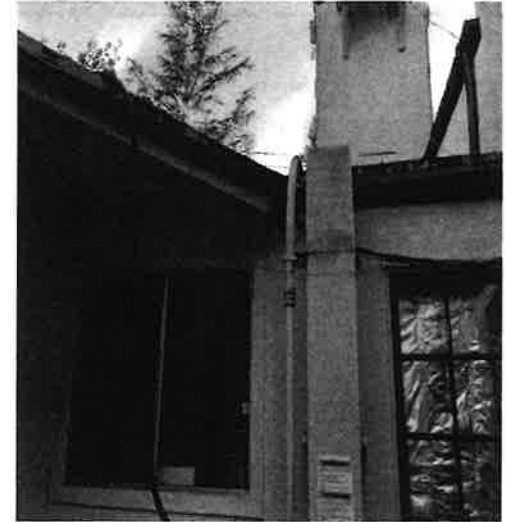
Exposed wiring

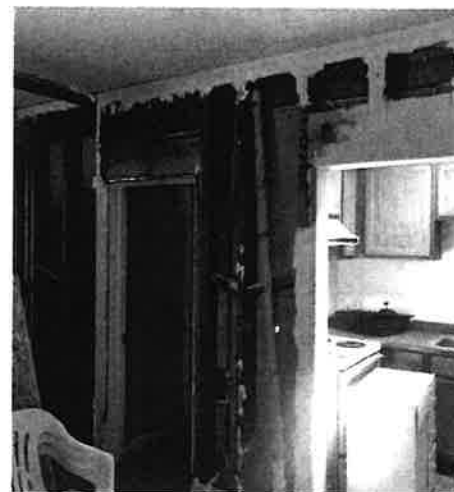
Partial demolition

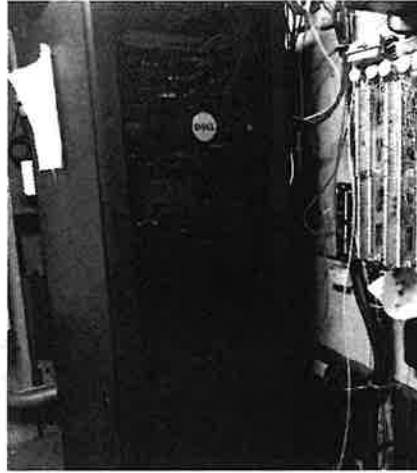
Clearance conflict
