PROPERTY CONDITION ASSESSMENT

Conditions Assessment Report

Ross Public Safety Building

33 Sir Francis Drake Blvd.
Ross, CA
ZFA Project: 16523.00

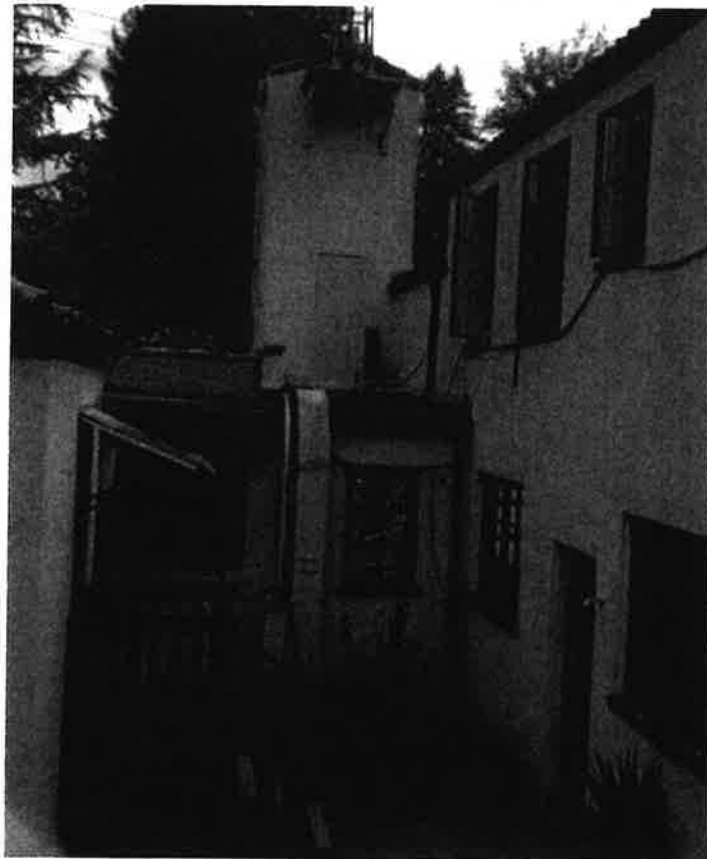
Image 6: Infill between central and north wing

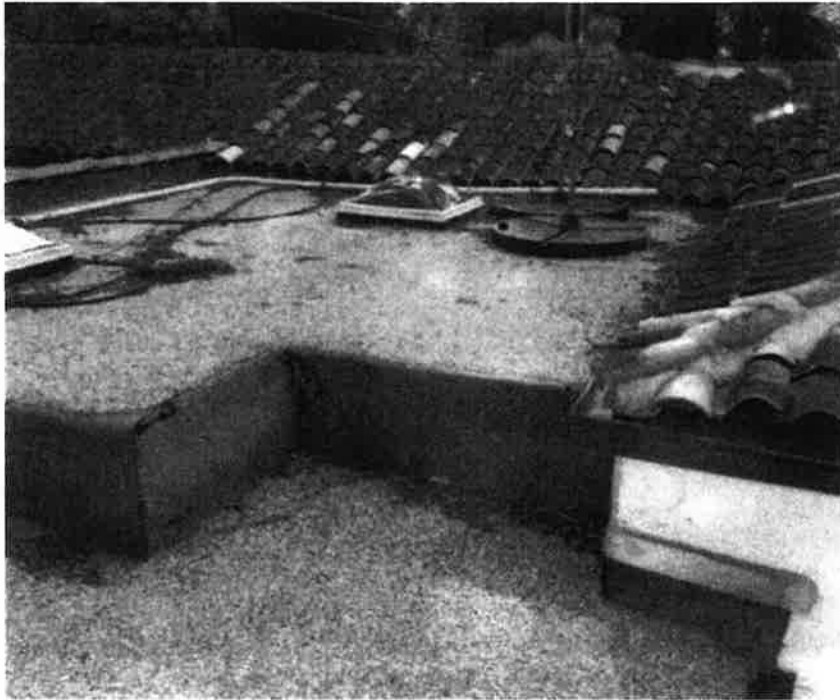
Image 7: Infill construction roof between central and south wing

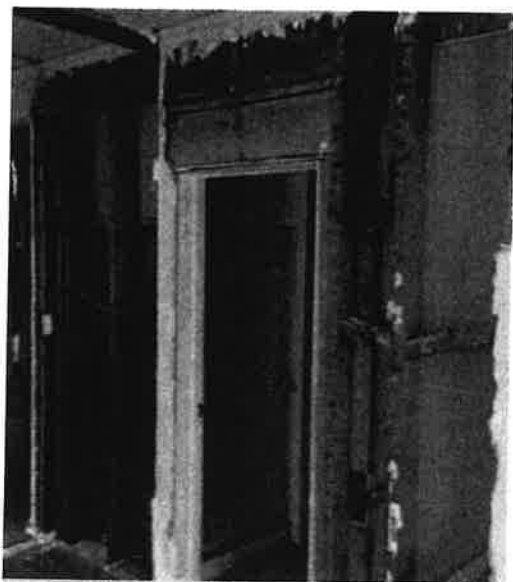
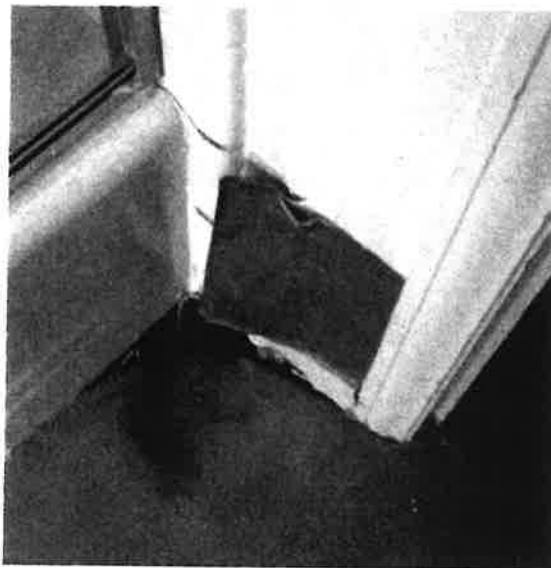
Image 9 and 10: South wing – Interior substandard construction

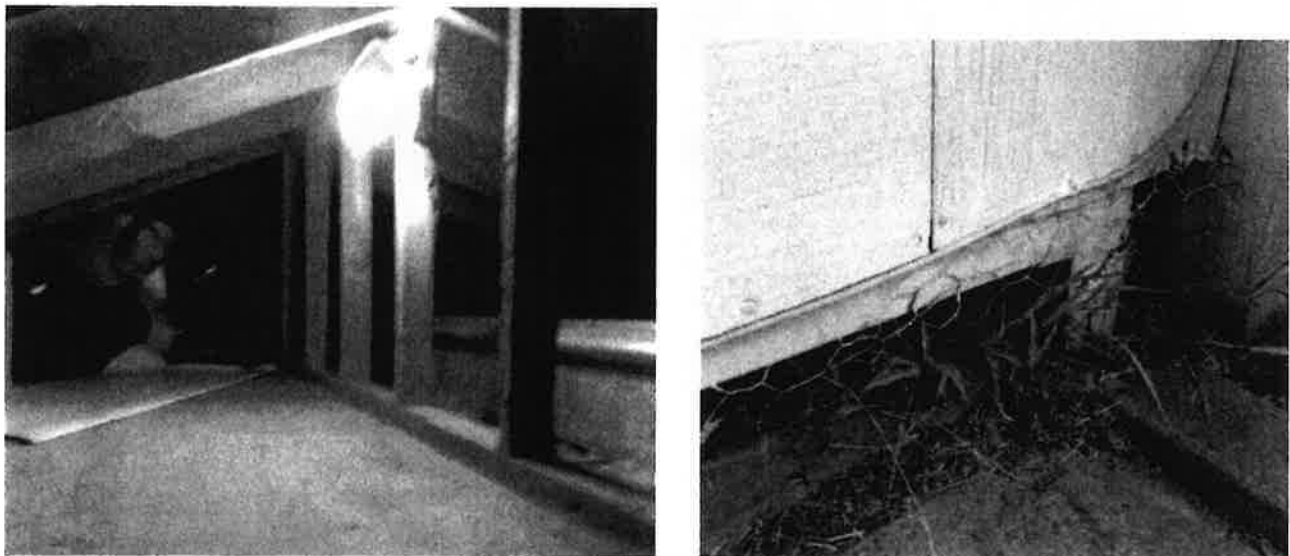
Image 15 and 16: Expansion and Infill – Roof framing and infill construction

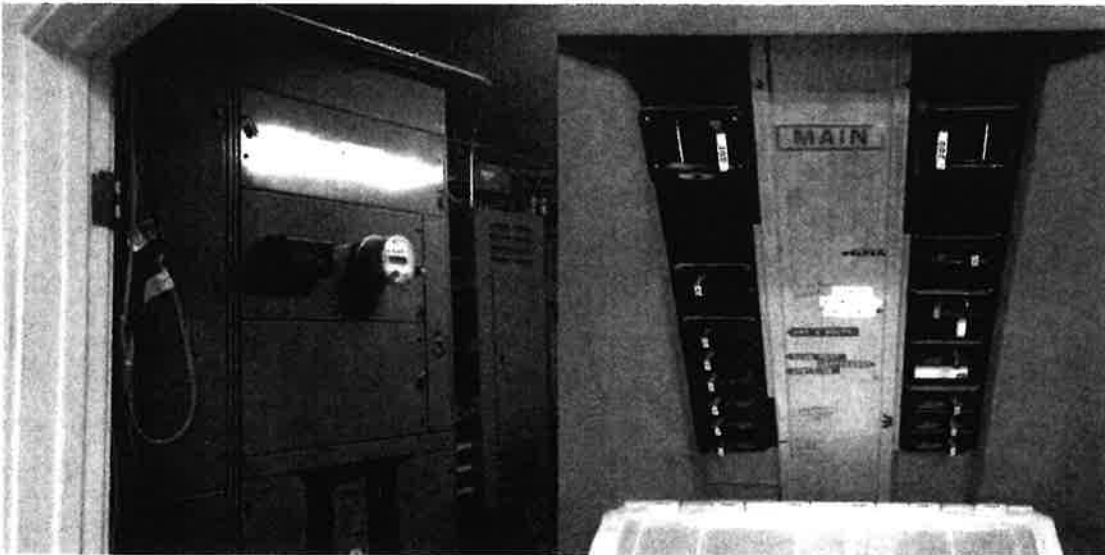
- a. The building electrical main service is provided by PG&E and feeds a 400-ampere main switchboard with a service voltage of 120/240V, single-phase. The switchboard is located in the main electrical room of the Fire Station portion of the building. The main circuit breaker is rated at 300 amperes and there is a secondary main circuit breaker rated at 300 amperes for the emergency generator feed. The switchboard is manufactured by Federal Pacific. Although vintage, the board showed no noticeable deficiencies. The utility service meter is #1003173037.

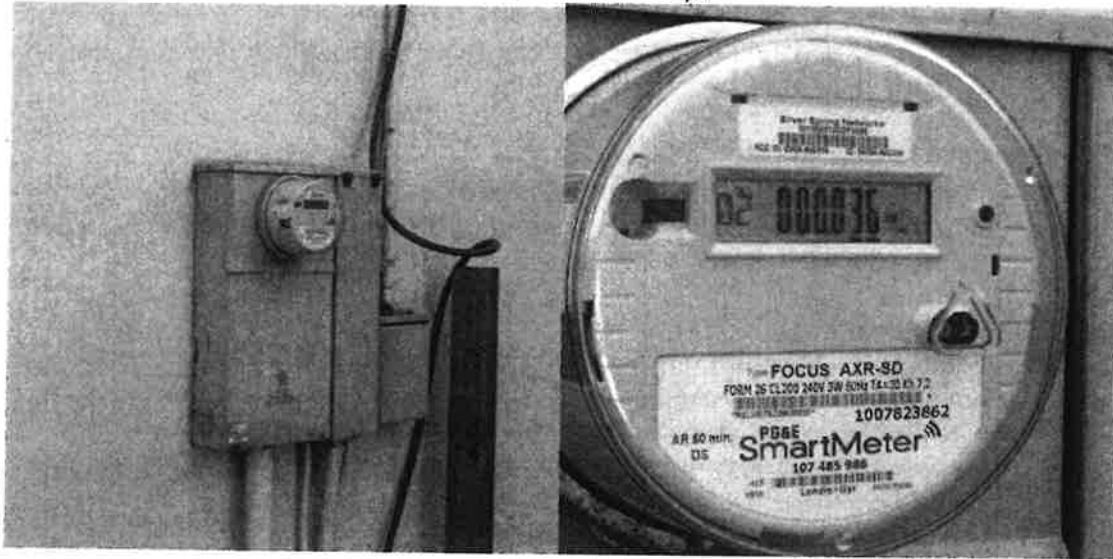
- b. A small 120/240V, single-phase exterior service is fed underground and is located on the backside of Apartment A. The service was originally fed overhead and the former service conductors are cut at the weather-head. The service has a Smart Meter #1007823862. It is unclear as to what this service feeds, but might feed the panels in the apartments.

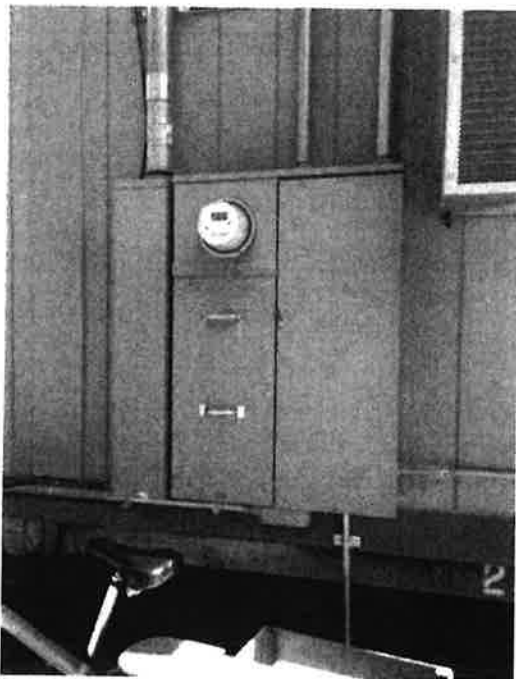
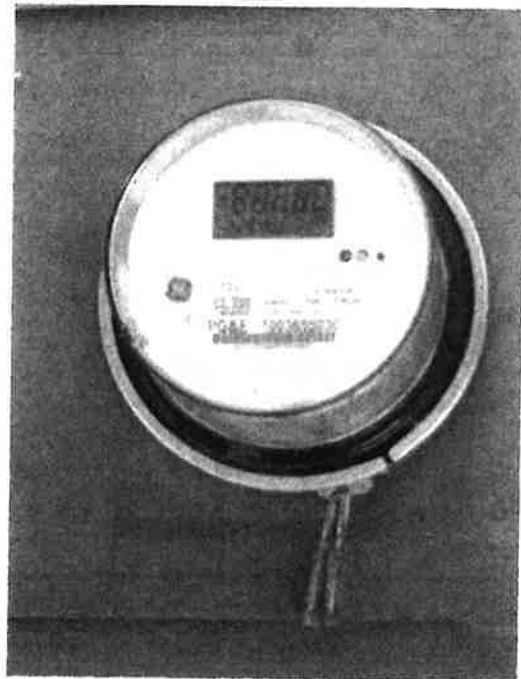
- c. Another small 120/240V, single-phase exterior service is fed overhead and is located on the backside of the portable unit near Apartment B. The service meter is #10036550302.

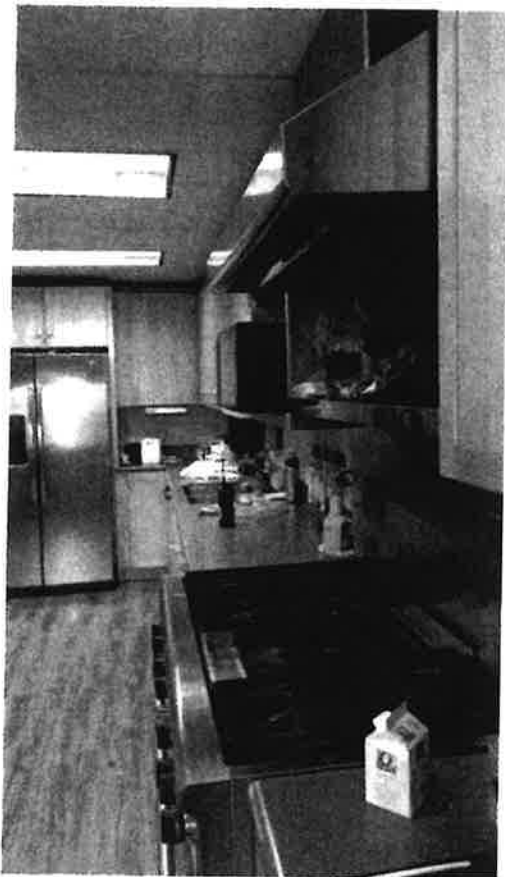
Figure 1.

- The kitchen is provided with a stainless steel hood over the existing gas-fired range. Currently the hood does not extend 6" past the front edge or sides of the range as recommended by engineering best practices (figure 1). The age of the hood could not be determined.

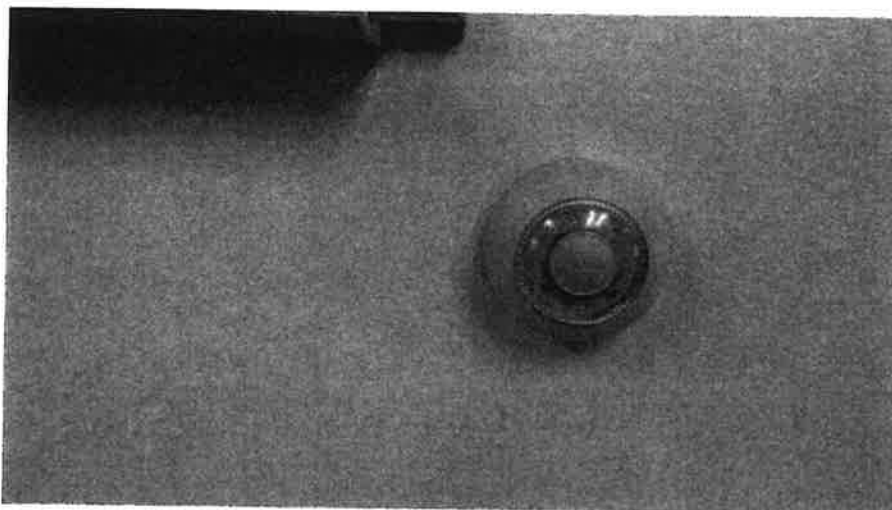
Figure 2.

- Existing HVAC controls are a combination of thermostats ranging from programmable thermostats to mercury thermostats (figure 2). The HVAC controls are antiquated and do not meet current Title 24 requirements.

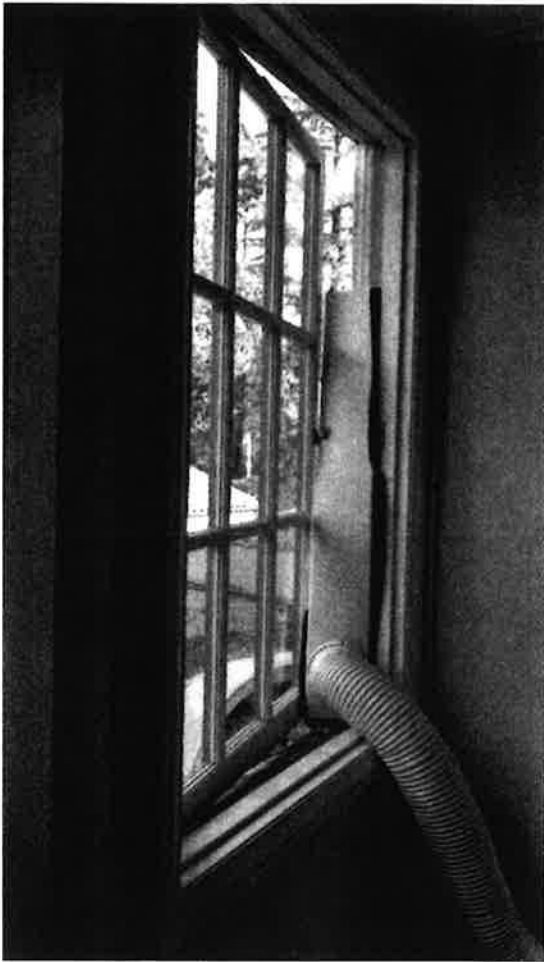
Figure 3.

- As it currently exists, there is a dehumidification unit located in the hallway of the residential portion of the building on the second floor. The unit is currently ducted out through a permanently open unit that is not sealed properly (figure 3).

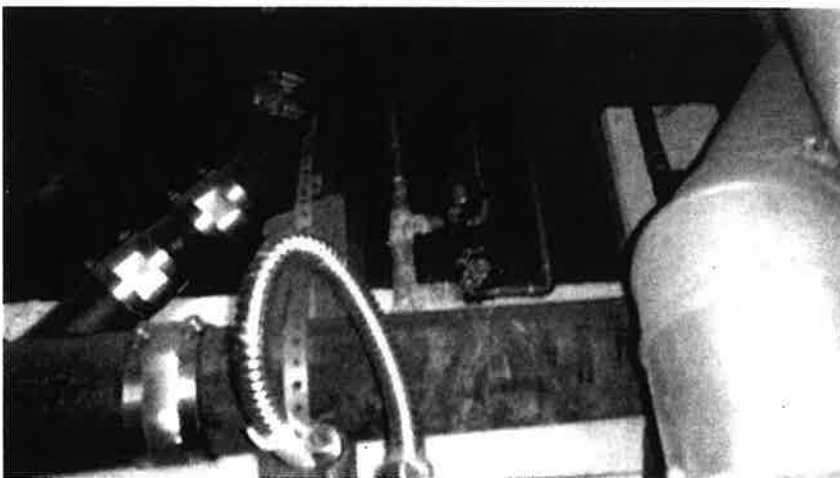
Figure 4.

- The existing sanitary sewer and vent piping was observed as cast iron with heavy duty couplings.
- The existing domestic water systems was observed as soldered copper system. Locations that were observable demonstrated corrosion (figure 4).

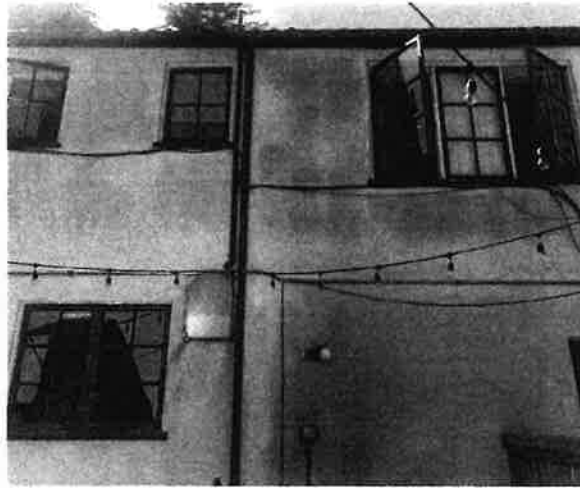
Exposed wiring, faded paint

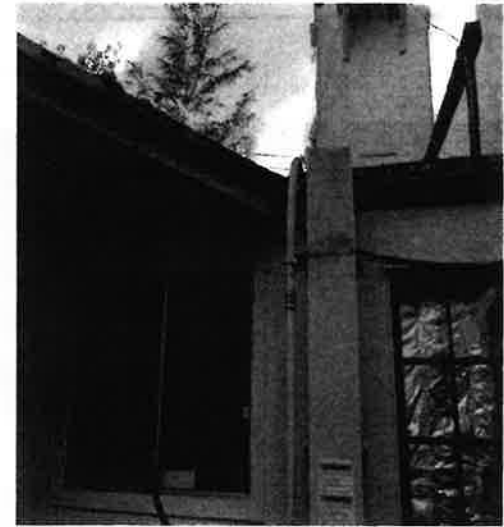
Exposed wiring

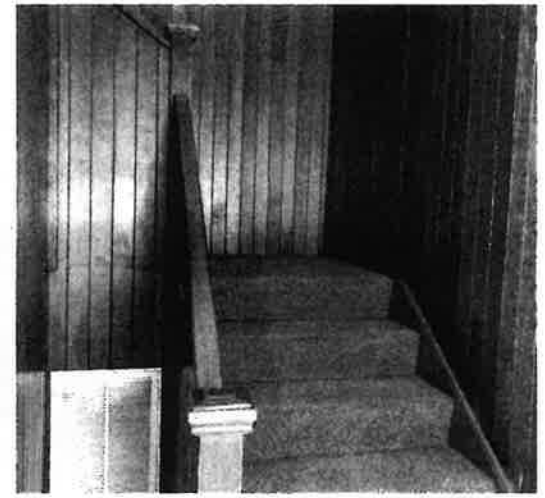
Non-compliant ADA stairs

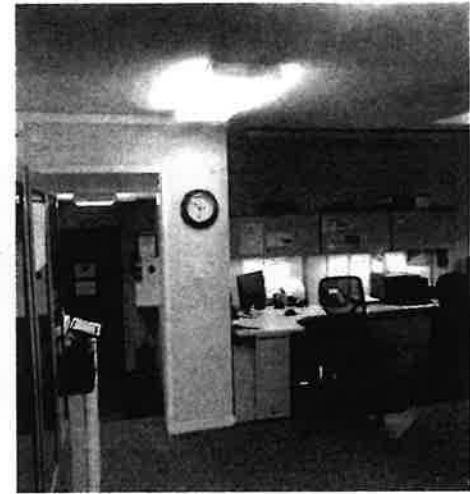
Moisture stains

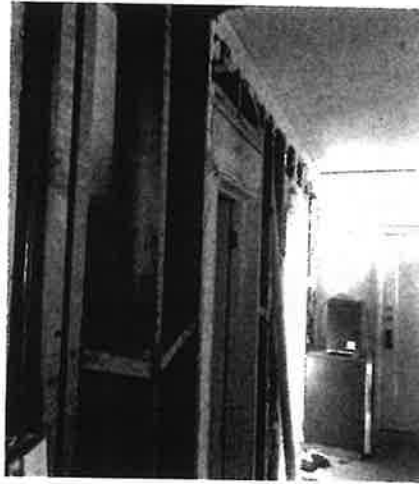
Water Damage

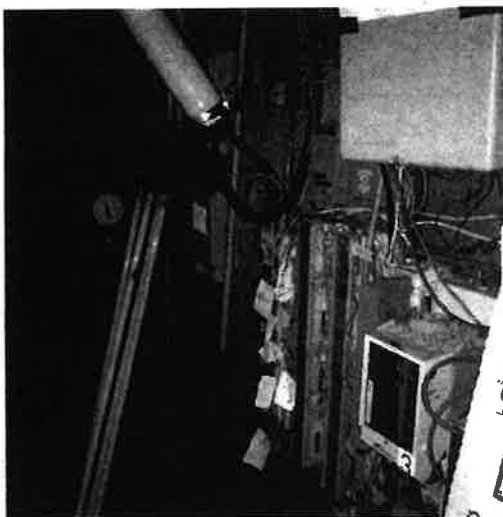
Exposed wires and unclear pathways

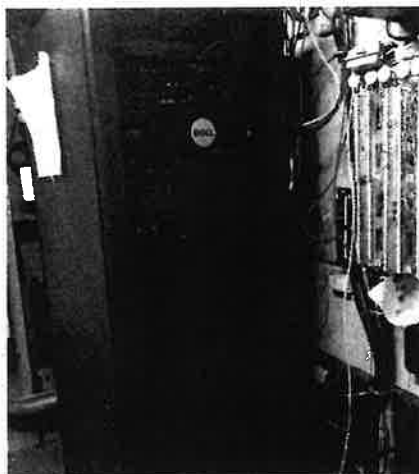
Clearance conflict

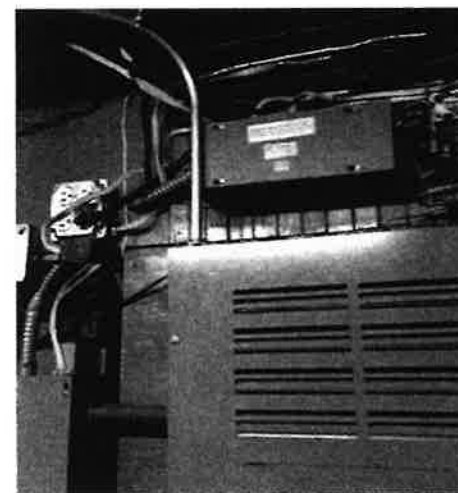
Exposed wires

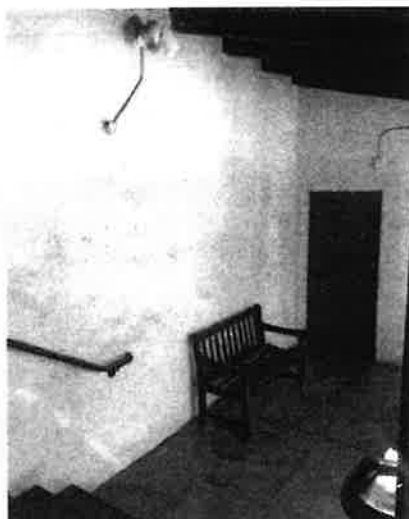
Faded plaster paint
